Hope Creek Circulating Water Pipeline 2013 Carbon Fiber Upgrade

Corporate Program Manager- Engineering Services, Piping
PSEG Nuclear Salem and Hope Creek Generating Stations
James.melchionna@pseg.com

Vice President- Pipeline Solutions
STRUCTURAL TECHNOLOGIES
apridmore@structural.net
714-869-8824

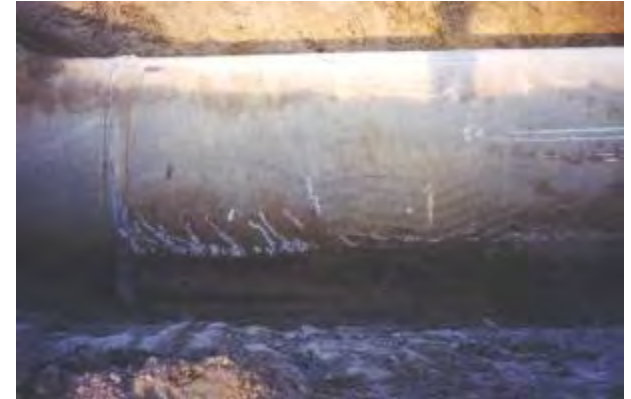
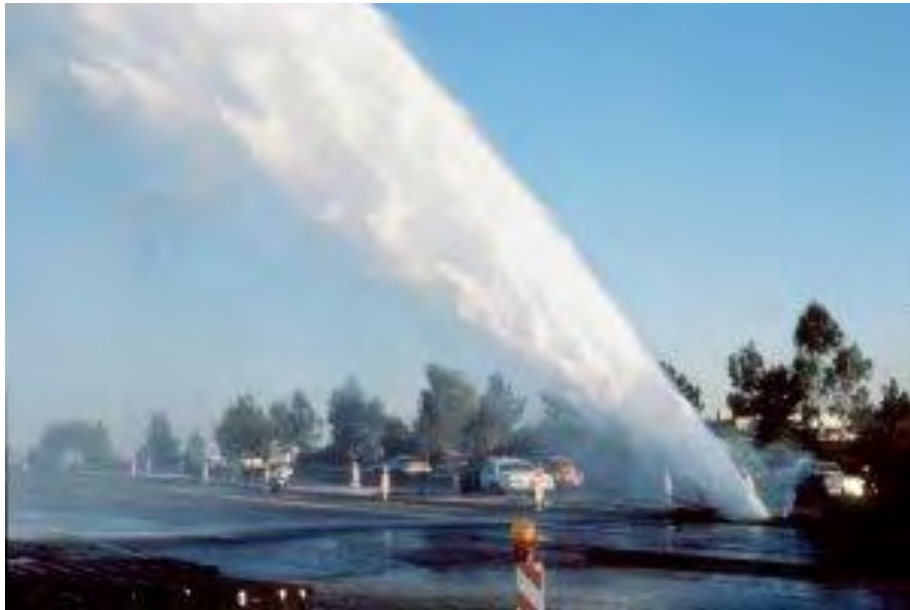
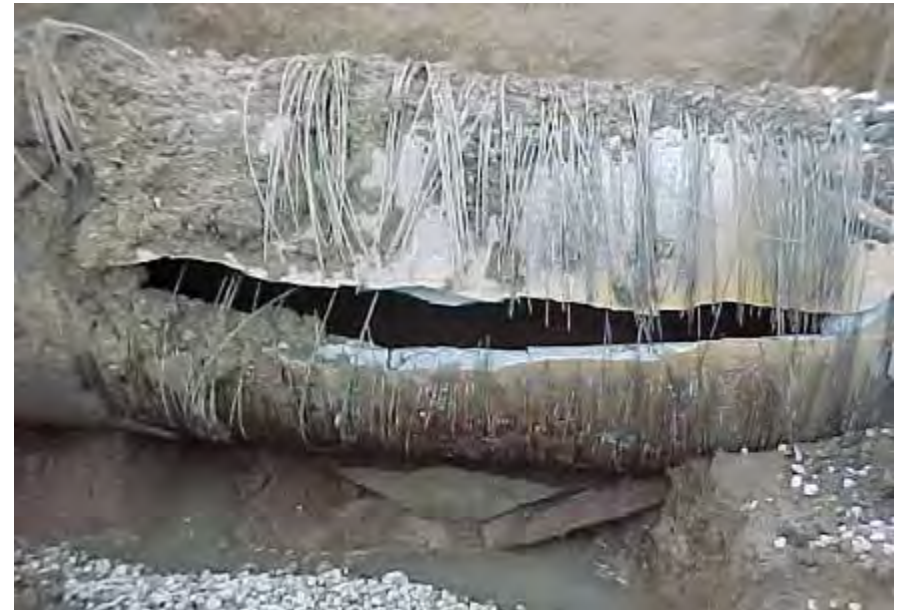
Background- PCCP Deterioration

- Cracking of Outer Mortar
- Corrosion or Embrittlement of Wires
- **Wires Break**
- Mortar Coating Delaminates
- Concrete Core Delaminates
- Core Cracks
- Failure

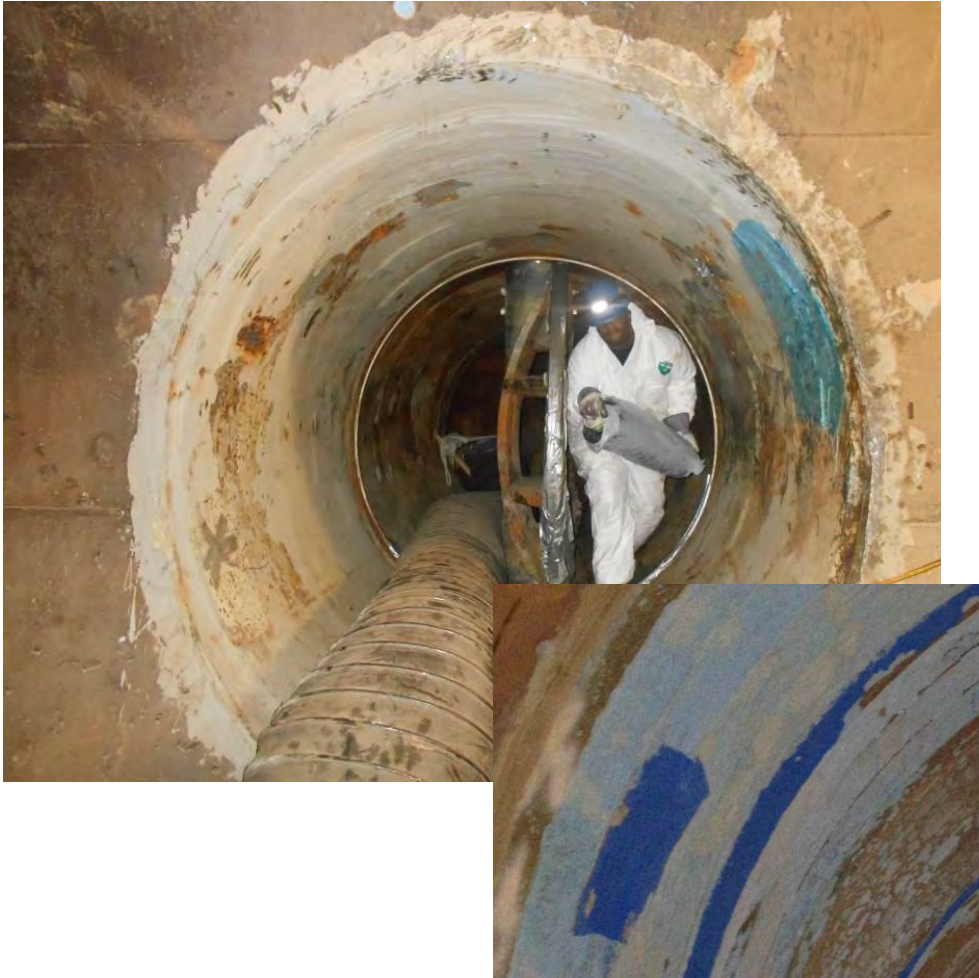
- Materials, personnel, and ventilation equipment all routed through a single point of entry
- Main access to the circulating water pipe required navigation through a butterfly valve
- Substrate had buildup of existing epoxy (remainder of failed carbon fiber lining system), sometimes over 1/2in thick
- Exact condition of substrate unknown prior to removal of coating

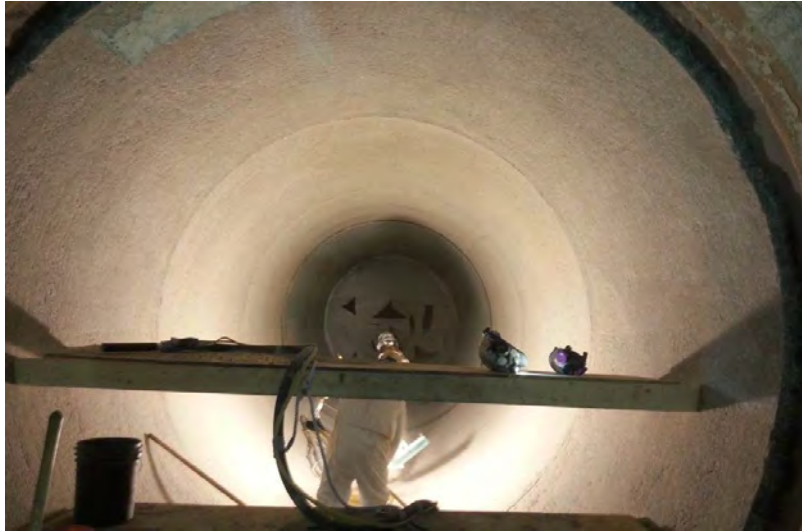
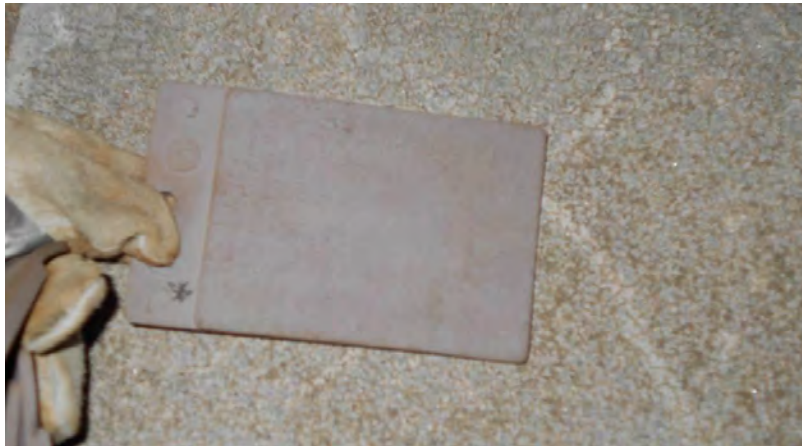
Key Project Step: Surface Preparation

- All prepared concrete substrates achieved a minimum surface profile of ICRI CSP 3
- All substrates cleaned and dried prior to installation of CFRP system

- Surface preparation performed using Sponge Blasting to minimize airborne particulates and to avoid utilizing a separate surface preparation method for end joint details

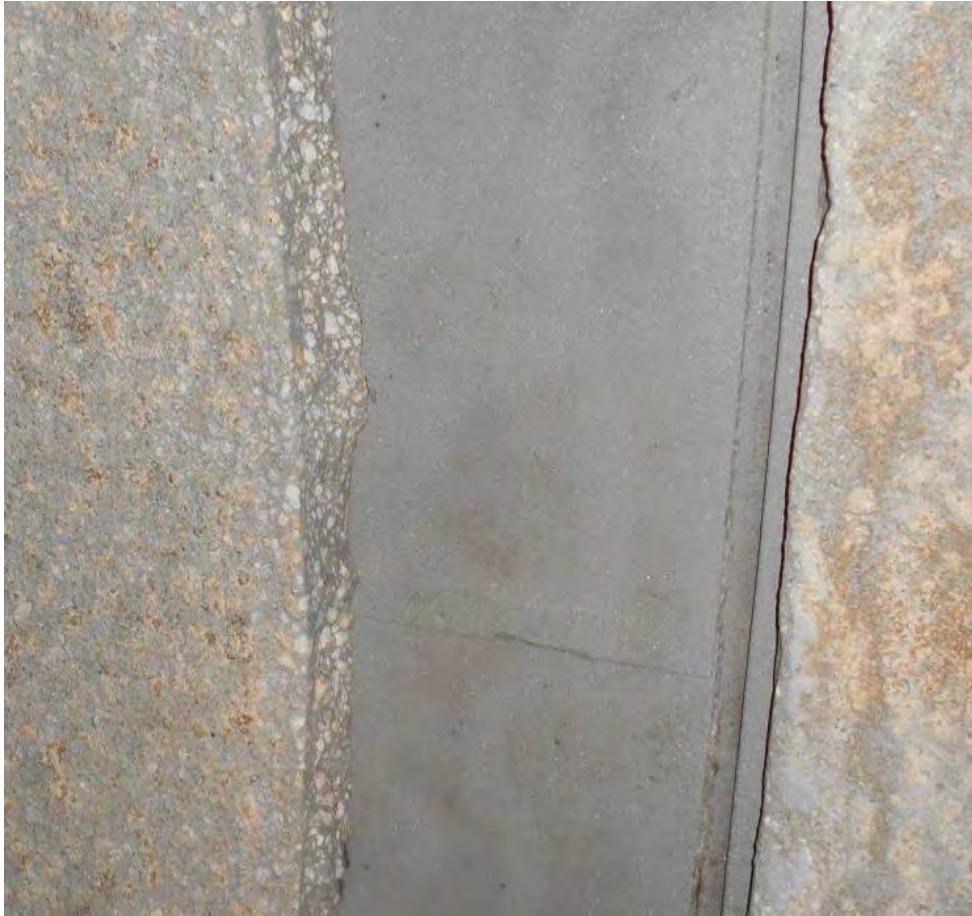
Key Project Step: Surface Preparation

- All prepared steel surfaces achieved a near white metal blast SP10 and a minimum surface roughness of 2 mils
- All substrates cleaned and dried prior to installation of CFRP system

- CFRP lining system terminates into the steel substrate to ensure water tightness

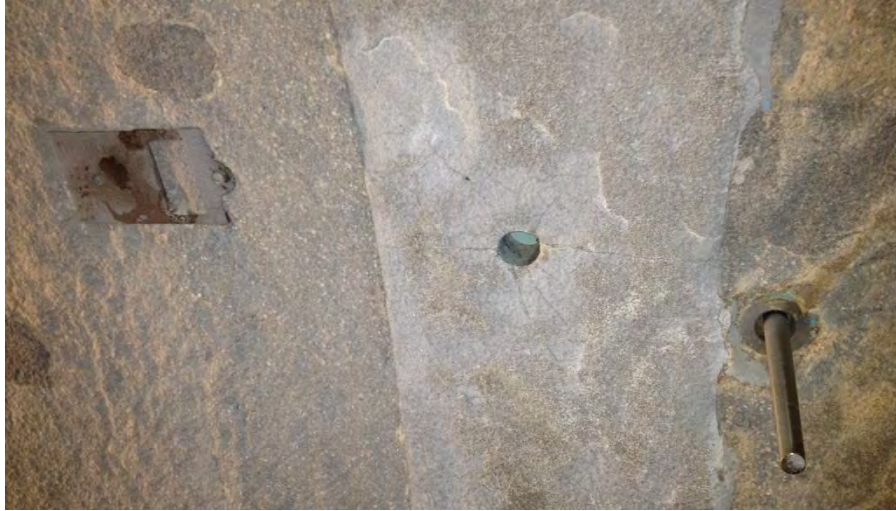
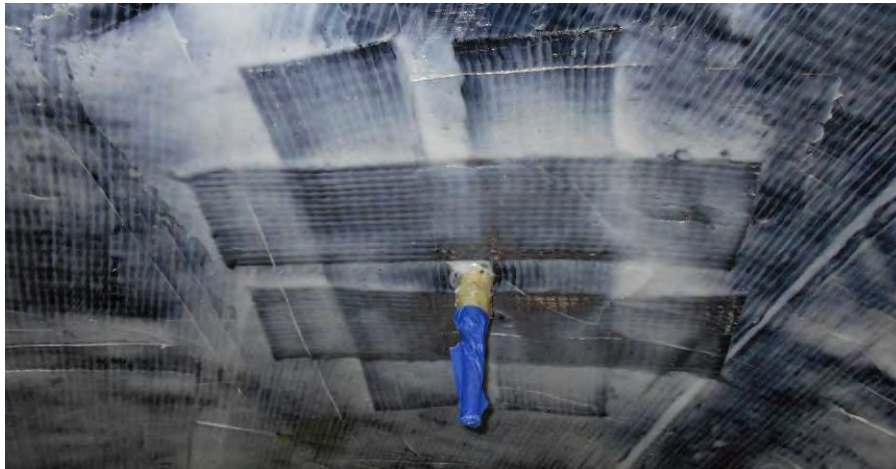
- Extensive pitting and concrete patches observed on prepared substrate
- Additional details identified that were not shown on drawings
- Specialty detailing to accommodate thermowell was designed after construction began

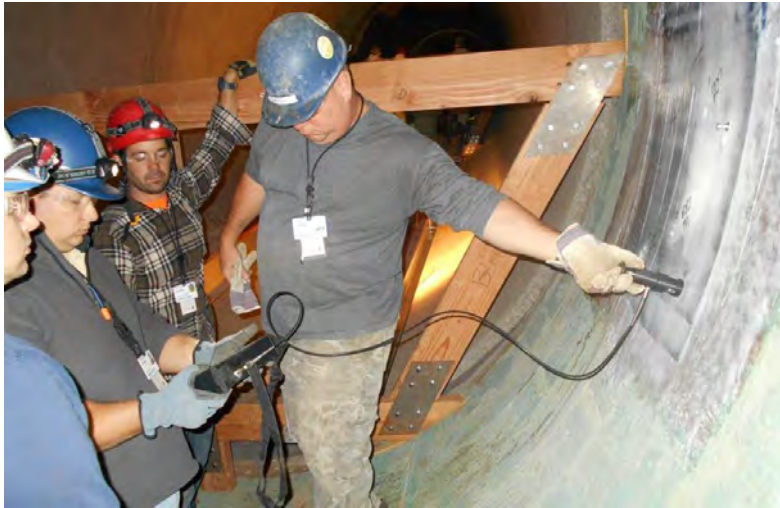
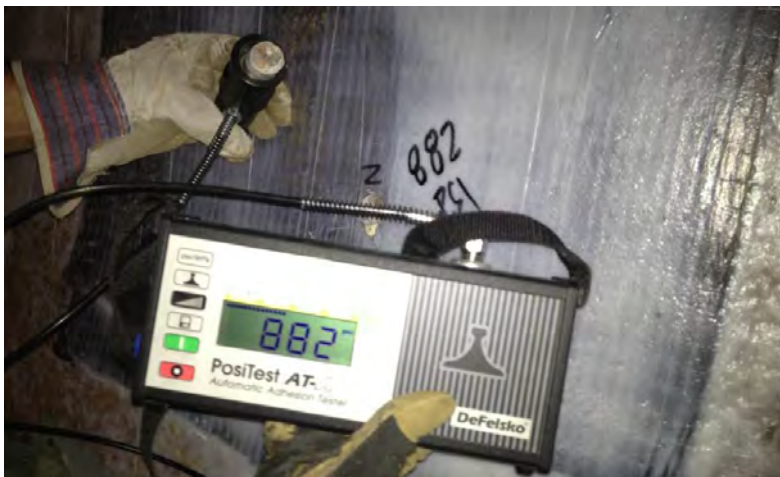
Key Project Step: Adhesion Testing

- A minimum of three (3) test pulls performed at three separate test regions
- Failure mode documented
- Minimum pull-off test of 200 psi required

- Surface preparation is verified by performing an adhesion test per ASTM D4541 on an adjacent section of prepared pipe

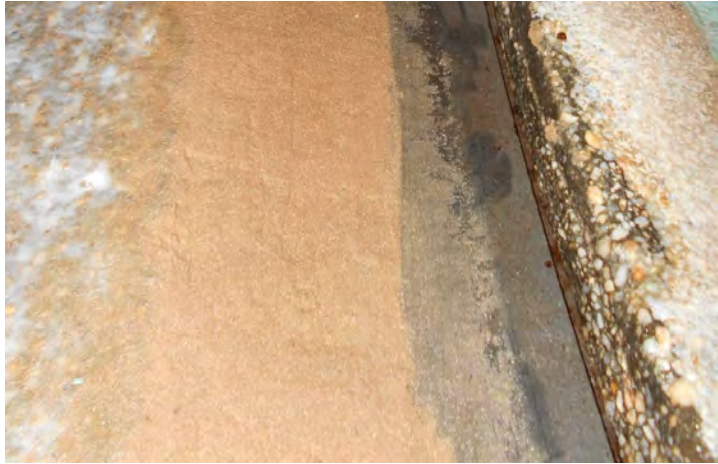
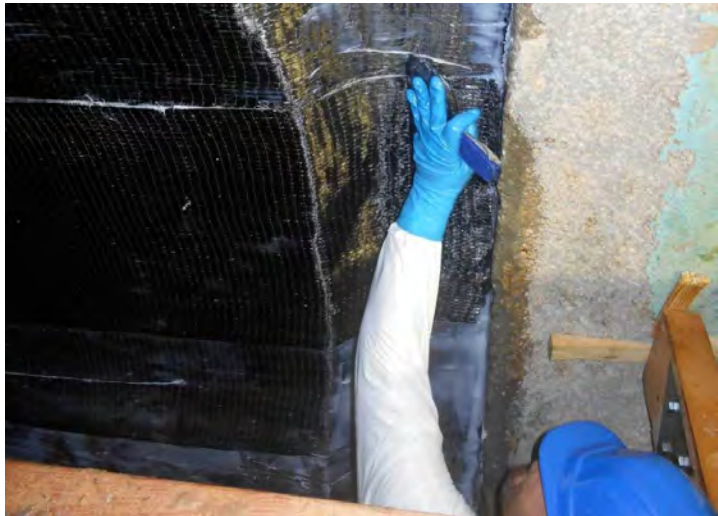
Key Project Step: End Joint Details

- Slope of epoxy mortar verified (2:1 slope)
- Air temperature, and surface temperature documented (min of 40°F)
- Humidity in pipe monitored (min of 5°F above dew point)

- Epoxy mortar in joint region used to create a sloped transition for the CFRP
- Glass layer installed in direct contact with steel substrate to create a dielectric barrier between the CFRP and steel
- All layers of longitudinal and circumferential CFRP installed onto the main pipe are also installed into the joint

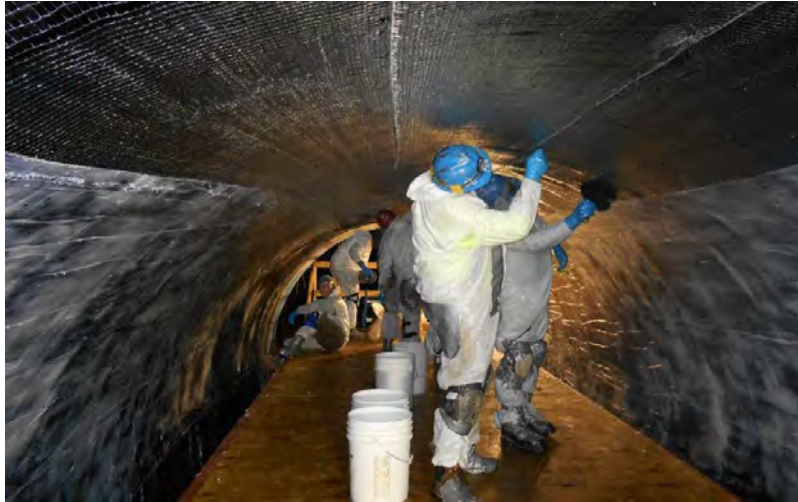
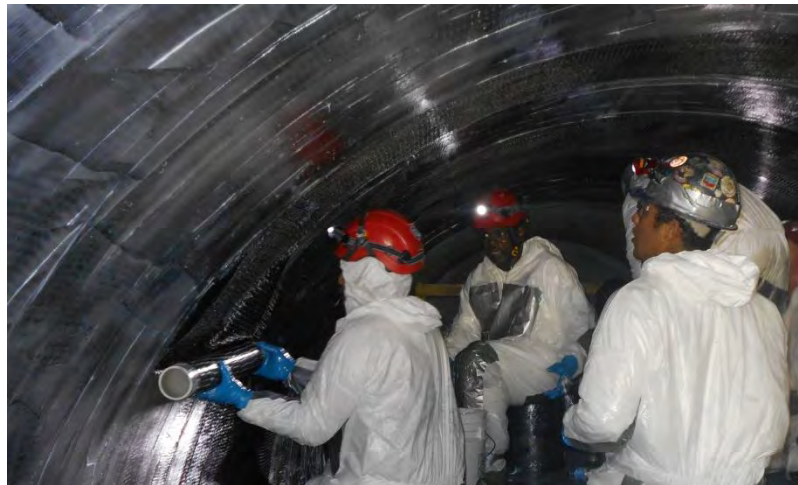
Key Project Step: CFRP Installation

- Air temperature, surface temperature, and humidity during installation documented
- Alignment of CFRP layers observed (maximum of 5 degree misalignment)
- Minimum development length of 12in in fiber direction

- Unidirectional mechanically saturated carbon fiber fabric installed in both longitudinal and circumferential directions
- CFRP design serves as stand alone system to resist 100psi internal pressure and - 14.7 psi vacuum pressure without reliance on host pipe
