STRUCTURAL REPAIRS FOR COURTHOUSE SQUARE

By Tarek Alkhrdaji, Ph.D., P.E.

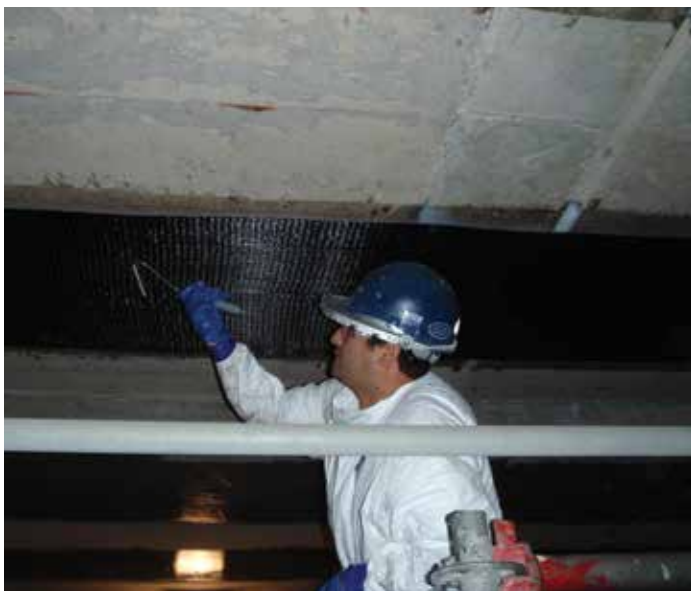
Installation of the FRP Composite Strengthening System.

- **Slab Bending Capacity** – Several locations were identified that required additional tension reinforcement at the top or bottom sides of existing slabs. Flexural strengthening of slabs was achieved using externally bonded fiber reinforced polymer (FRP) reinforcement. The V-Wrap externally bonded FRP composites supplied by Structural Technologies provided a very low profile and did not change the appearance of the slabs or interfere with floor finishes. The design of the FRP was achieved using the industry-recognized ACI 440.2R-08 design guide.

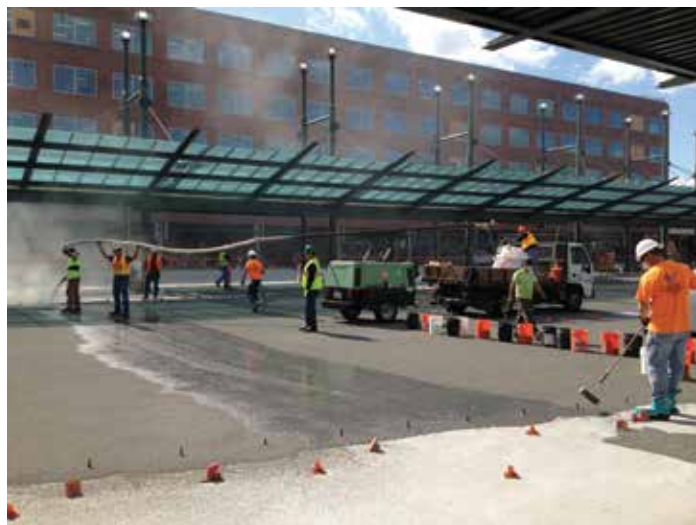
Crews apply a traffic-bearing coating in the public transportation area.

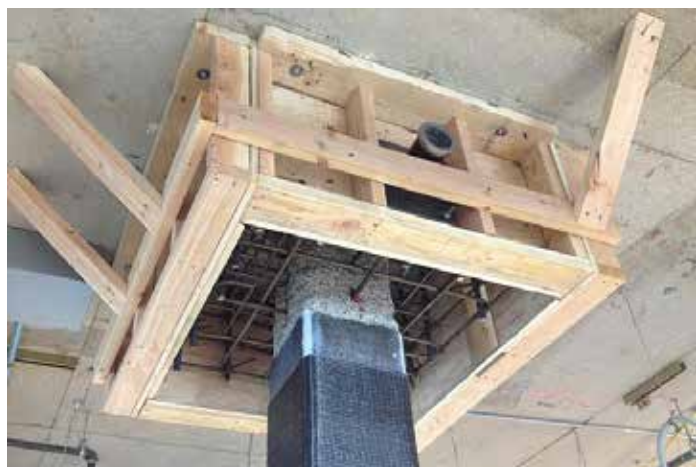
Columns wrapped with FRP for axial strength and enlarged for punching shear.

axial and/or bending strength, or did not satisfy stiffness requirements. Column strengthening was achieved by installing 6- to 10-inch thick reinforced concrete jackets to increase the axial and bending strengths, and to increase buckling resistance of the columns. Similar to drop panels, the concrete jacket was placed using the form-and-pump technique. Specialized self-compacting concrete (SCC)

material was developed, and used to pressurize the formwork and to produce optimum bond between the existing and new concrete. The size of the concrete jacket varied to satisfy strength requirements and to minimize interference with the existing MEP, building finishes, and parking spaces. One-sided, two sided, and full jackets were used, as needed, to address these conditions.

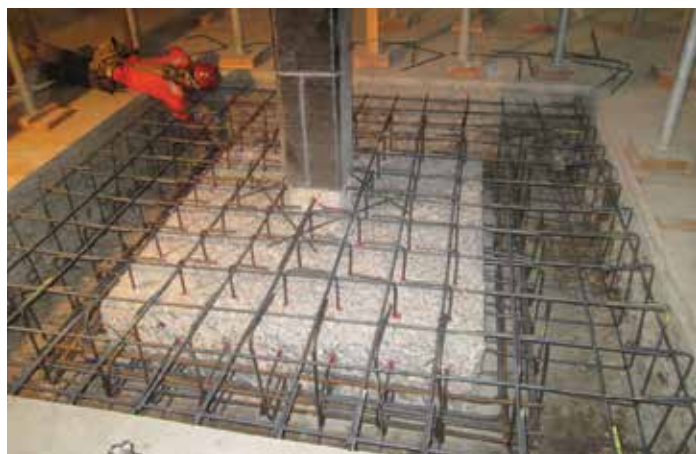
Enlargement systems were used to strengthen the column footers in the parking structure.

- **Isolated Footings** – several of the existing column footings were found to be deficient in punching shear and in bearing capacity. These issues were resolved by enlarging the size and depth of the existing footings to increase their shear, flexural and bearing strengths.

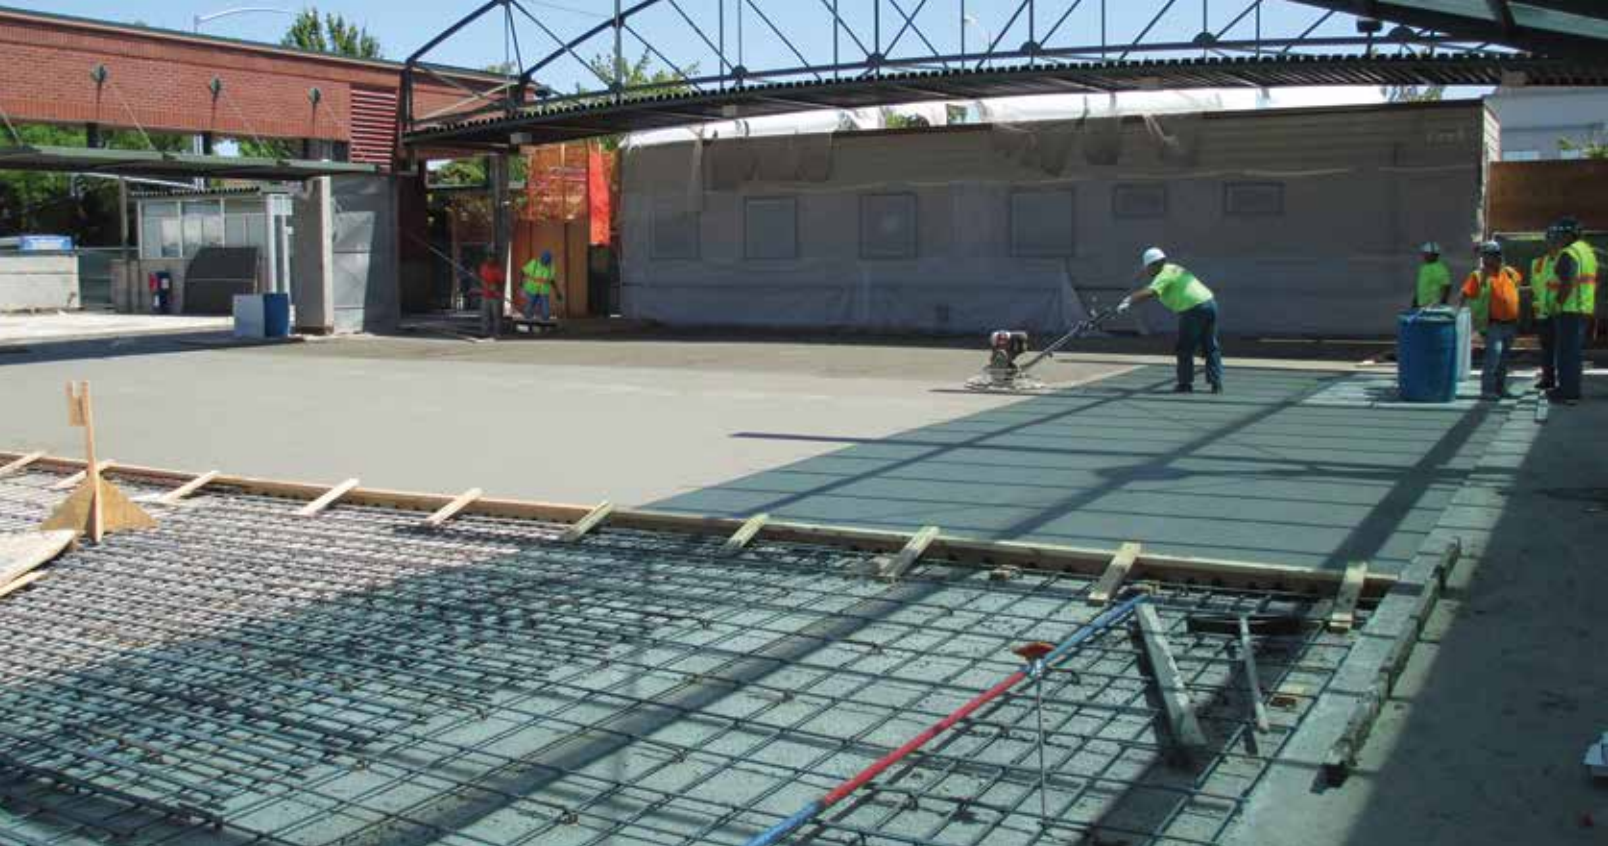
Placement of bonded overlay over the parking structure created a strengthened deck for the public transportation area.

Strengthening of the transit mall slab included removal of the existing concrete overlay, sand and pavers, and installation of a new 5-inch thick bonded overlay, increasing the slab thickness from 10 inches to 15 inches. To ensure composite performance

of the existing slab with the new reinforced topping, the top side of the existing slab was roughened to ¼-inch amplitude, and steel dowels were installed in both directions. Using this approach, the total superimposed dead load was reduced while increasing the flexural and punching shear capacities of the slab. The concrete overlay was finished with an epoxy-based heavy traffic coating. Cast-in-place shear capitals were also installed at several columns where high punching shear deficiency was identified. In addition, externally bonded FRP was utilized at the mid-span regions to increase the flexural capacity of the slab. All existing foundation wall cracks were repaired using epoxy injection.
