Tucson Water's Strengthening Approach to Address Thrust Restraint for PCCP

6. REHABILITATION OF THE 84-IN CAP WEST MAIN

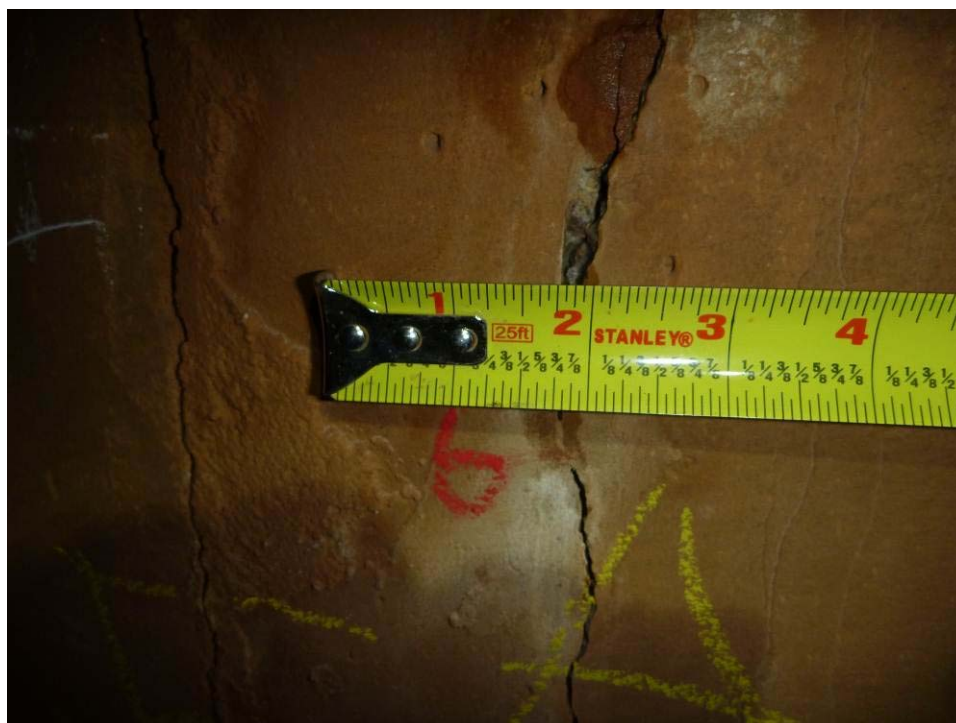
In late 2012, Tucson also scheduled a planned outage of a 66" through 96" pipeline to install a newly designed acoustic monitoring system as an upgrade to current acoustic monitoring equipment. During internal visual inspections, Tucson Water crews identified a pipeline leak, shown in Figure 2. The leak was identified as water penetrating the pipe wall from the outside.

Figure 2. Observed joint damage (Photo Credit: Hector Posada of Tucson Water)

A more thorough investigation revealed full circumferential cracks, with longitudinal cracks in the vicinity of a manufactured blow-off. The Condition Assessment team concluded that more information was needed to perform a failure analysis. The project engineer, Simpson Gumpertz and Heger (SGH) found that within a pipeline span of approximately 200 linear feet, pipe segments from the original C-301 design were restrained improperly and the pipe was unable to restrain the thrust forces on two adjacent 45 degree bends. SGH was able to simulate the

A CFRP liner was selected specifically because it could be installed rapidly, allowing the pipe to be put back in service in a very short time. In this case, the implementation of the CFRP upgrade was completed on an emergency basis. The normal planning, notifications, and construction time that would have been needed for a routine replacement of the damaged pipe segment made the replacement option infeasible.

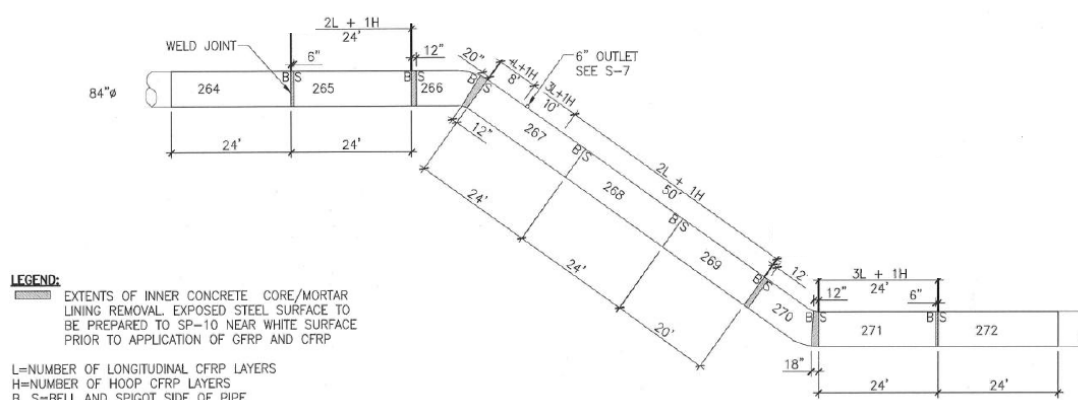
Figure 3. Overall project scope

As detailed above, a key aspect of this project was that the longitudinal deficiencies within the 84-inch pipeline segment were found to be caused by inadequately installed thrust restraint. The longitudinal forces acting on the pipeline were not properly resisted by thrust blocks and original pipe design, therefore the pipe segments developed circumferential cracks at the pipe joints where the pipe sections were pulled apart by the thrust forces.

After the CFRP option was selected, the contractor had to provide a full design and technical submittal within a short period of time, as construction activities were to commence immediately. Design of the CFRP system was to take into account the longitudinal weakness as the primary driver and as such the majority of the reinforcement would utilize CFRP placed in the longitudinal direction. A benefit of CFRP lining systems is that the use of unidirectional material allows for the design to be customized to resist specific loadings in each direction. Figure 3 below details the repair area.

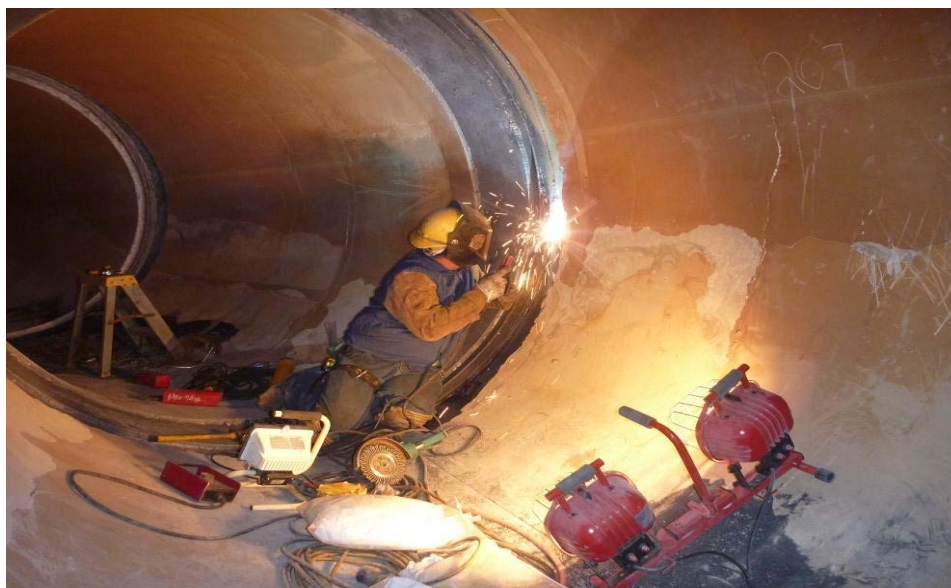
Figure 4. Welding of leaks in the joints prior to CFRP installation
(Photo Credit: Hector Posada of Tucson Water)

included the time required to fully cure the CFRP system. Prior to beginning the CFRP liner installation, the leaks had to be addressed; for this repair the steel cylinder at each leak was welded, as shown in Figure 4. Because the leak in the pipeline occurred in the joint region where the CFRP lining system terminated, welding of the joint was required to ensure leak-tightness of the overall system.

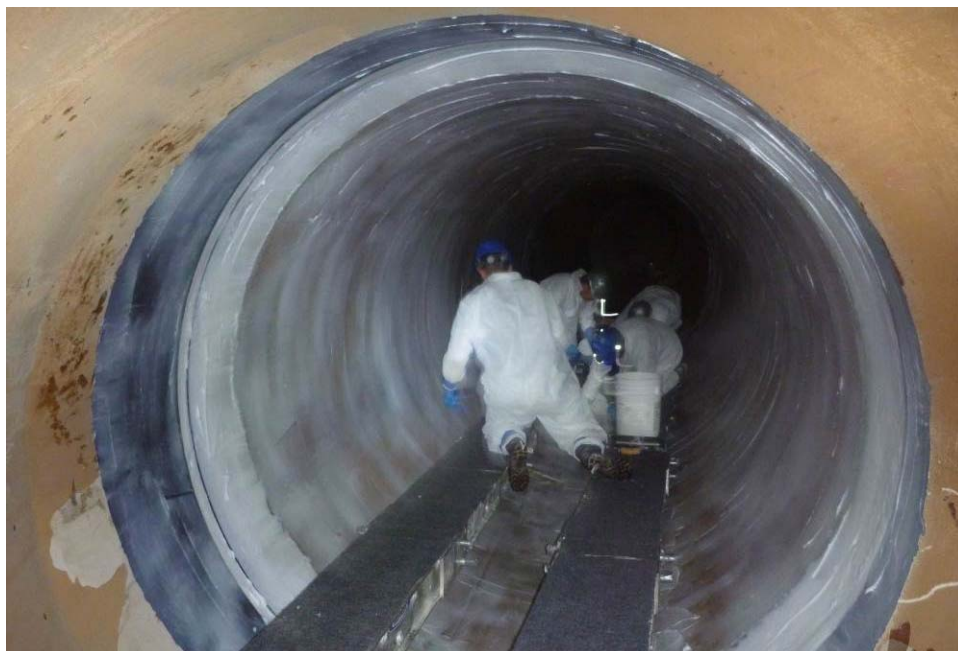
Figure 5. Installation of initial layer of thickened epoxy prior to installation of CFRP
(Photo Credit: Hector Posada of Tucson Water)

Figure 5 shows the scaffolding in place as a layer of epoxy is being applied. The first material to be installed as part of the CFRP system is a prime coat of epoxy followed by a layer of thickened epoxy, which is also depicted in Figure 5. Figure 6 shows the Tucson Water pipe following installation of the CFRP system.

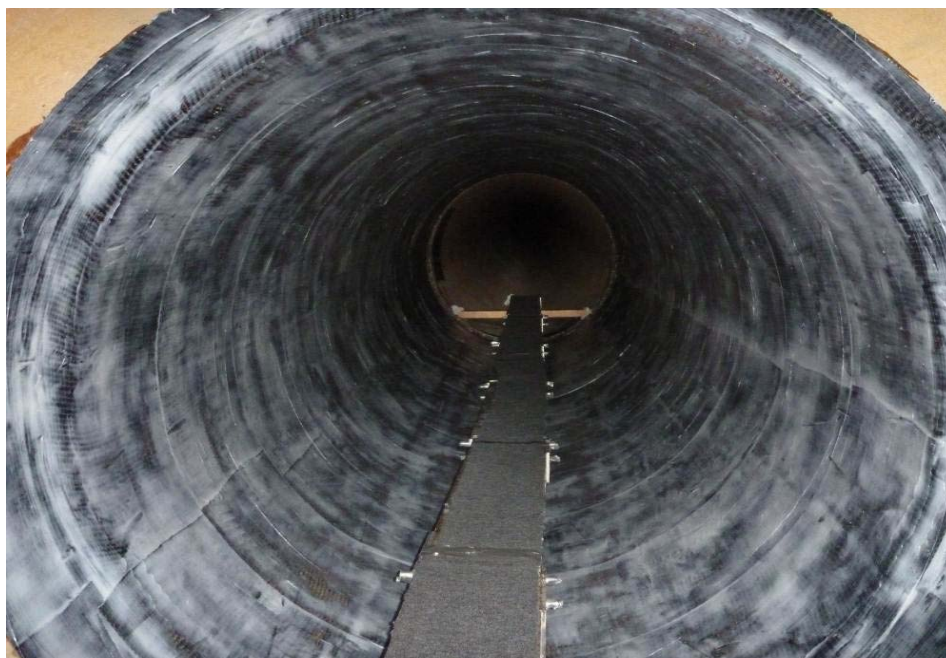
Figure 6. Completed CFRP lining (Photo Credit: Hector Posada of Tucson Water)

Immediately following application of the thickened epoxy, the first layer of longitudinal CFRP was installed. The design varied, depending on the region within the pipeline, between a nominal thickness 0.24in and 0.5in with the majority of the reinforcement in the longitudinal direction and a minimal amount of reinforcement in the hoop direction.

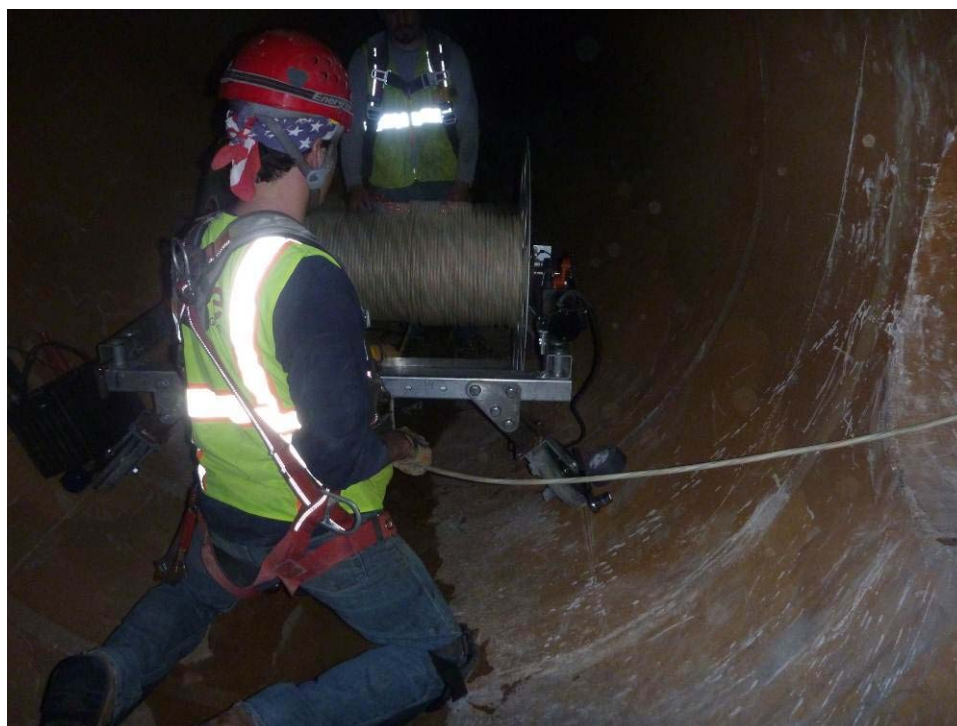
**Figure 9. Re-installation of acoustic fiber optic cable after rehabilitation work was complete
(Photo Credit: Hector Posada of Tucson Water)**

After the CF RP was fully cured, Tucson Water re-installed the fiber optic cable in the repair region. Figure 9, below, shows the cable installation taking place. The fiber optic cable in this region of the pipe is critical for monitoring the condition of the pipeline and ensuring system integrity between manned entry inspections of the system.
