PRESERVING DETROIT

Solution Stops Water Infiltration in Historic Detroit Building

BY BRENT ANDERSON

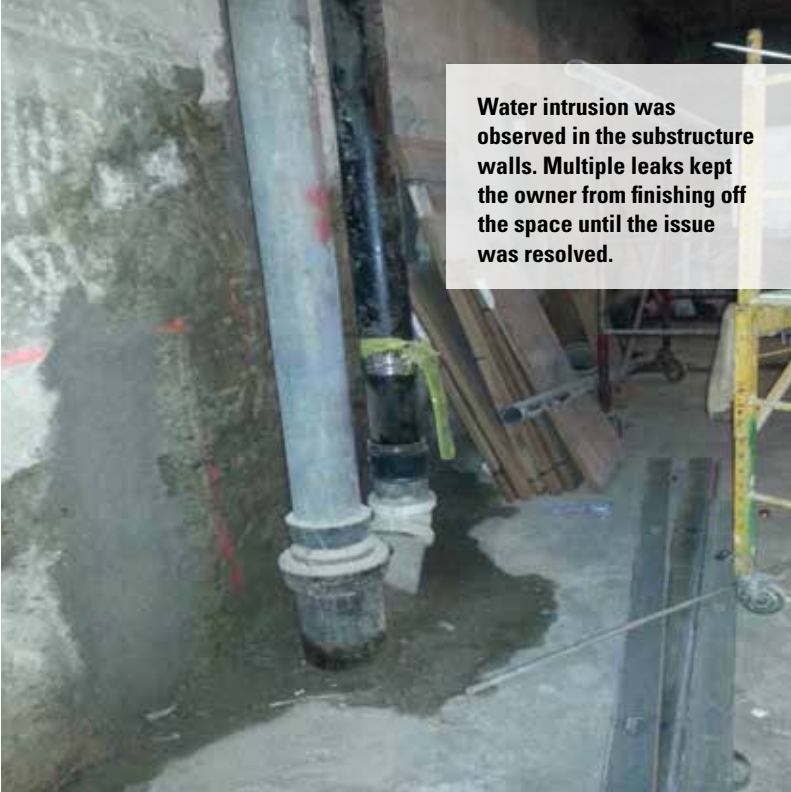
Water intrusion was observed in the substructure walls. Multiple leaks kept the owner from finishing off the space until the issue was resolved.

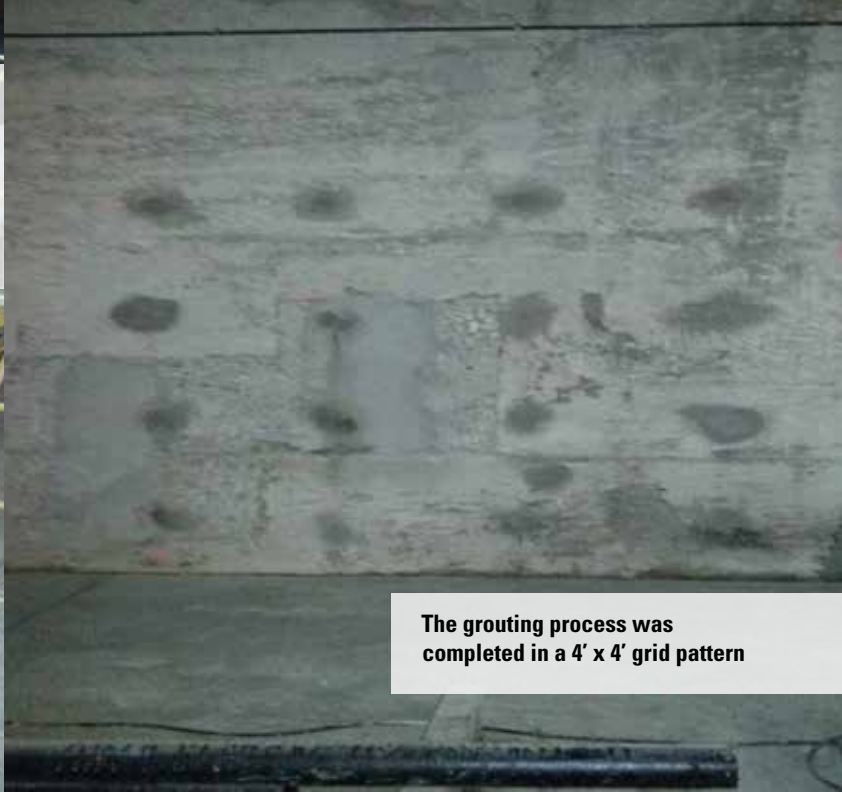
The grouting process was completed in a 4' x 4' grid pattern

Pullman crews pumped the grout beginning at the lowest point moving upwards. Pumping continued until the chemical grout was transmitted from port to port. Once transmission of the grout was visible, which was determined by the colorant intensity, shutoff valves were closed and the process continued throughout the grid pattern.

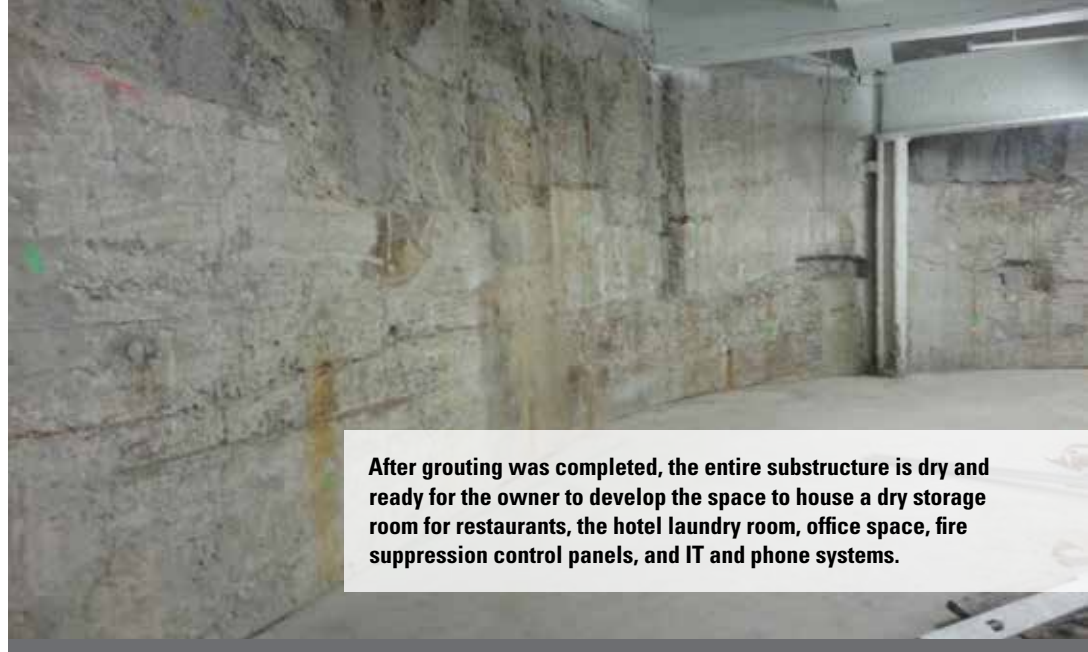
After grouting was completed, the entire substructure is dry and ready for the owner to develop the space to house a dry storage room for restaurants, the hotel laundry room, office space, fire suppression control panels, and IT and phone systems.
