# Predictive maintenance keeps plant operational

*At Xcel Energy's Monticello plant, the early diagnosis of vibrations led to preemptive pump repairs.*

### Repairs at Monticello

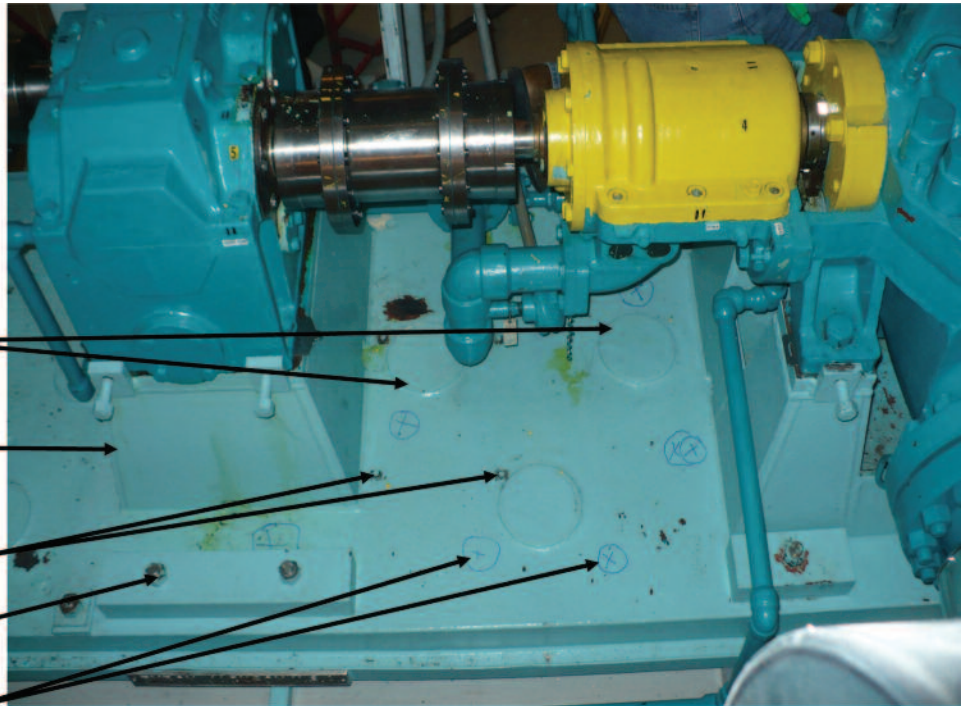
## HPCI Main Coolant Pump

Monticello's HPCI pump base was about 40 years old, and in the 1980s, it had experienced excessive vibrational issues. Additional anchor bolts were added to support the system. Despite those early corrections, two decades later, vibrations began approaching high levels. High-amplitude vibrations can cause the misalignment of pump seals and lead to uneven wear on bearings. Improperly repaired and aligned, the pump could wear out prematurely and cause critical safety equipment component failure. Because the HPCI pump is the first line of defense for a reactor vessel in cases where a loss of normal core coolant inventory occurs, it must remain operational.

Proper application of cementitious grout during equipment installation is important, as the grout must uniformly transfer loads and energy to the underlying foundation. Gaps, air pockets, and voids in general between the grout and the supporting metal base plate can cause stress and energy concentrations in adjacent areas. Over time, excess vibrational energy over these voids causes micro-cracks (delamination) in the supporting grout in adjacent areas. Eventually, vibrational amplitudes deteriorate the entire support mechanism.

- Metal Caps welded over Metal Base Plate, Vent And Supply Holes for Previous Cementitious Grouting
- Elevated Metal Pump Supports Welded to 1/4" Thick Metal Base Plate
- Location of 3/8" drill holes Through 1/4" Metal Base Plate for Epoxy Resin Injection
- Thickened Steel Base Plate, Leveling Rods Below Plate
- Location of Air Pockets and Voids Under Steel Base Plate

Repairs began during a planned plant shutdown. Structural's approach to lessening the equipment vibration included the injection of epoxy-based grout into the voids between the original grout and the skid to improve the bearing support for the skid. The repairs involved pressure injection and gravity fill of cracks, voids, and annular spaces. Spaces where concrete was removed were then repaired with cementitious grout. The pump equipment stayed in place during the repair, so the biggest challenge was to avoid lifting the steel plate while injecting the grout.

The successful grout repairs on the HPCI pump stiffened the base plate and moved the natural resonance frequency to where it needed to be to reduce vibrations.

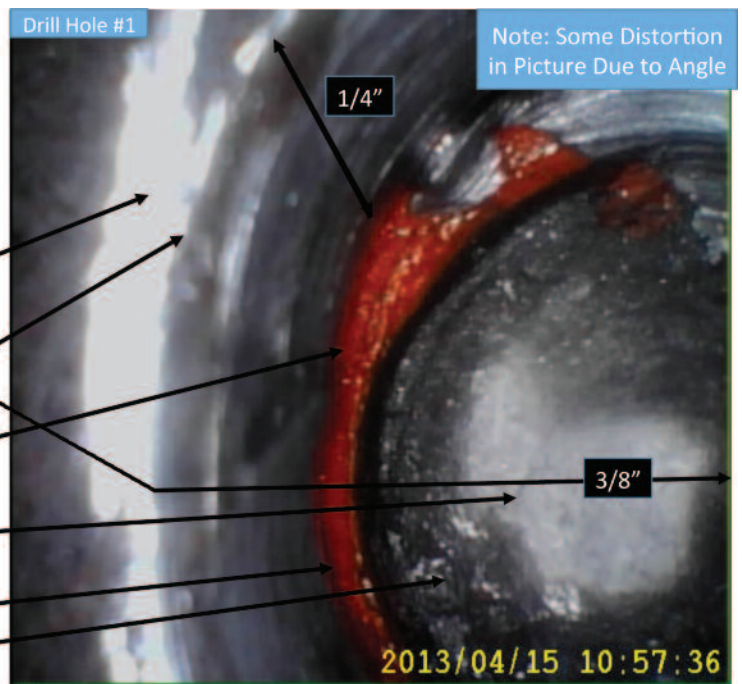
## Investigation Holes for Charge and Discharge Holes

The first step was to drill three pilot holes through the 1/4-inch metal base plate to examine the grout/metal interface. It was noted in all three test holes that corrosion existed at the grout/metal interface and micro-cracking of the cementitious material had occurred, allowing the base plate to vibrate excessively and create energy frequencies and amplitudes that were causing premature wear of the machinery power shafts, gaskets, and seals above the plate.

- 1/4" Thick Metal Base Plate after Paint Removal
- Grey Lead Based Paint was Removed From Vicinity of 1/4" Metal Base Plate Top Surface Prior to any Drilling
- 3/8" Diameter drill Hole Through 1/4" Metal Base Plate
- Steel Corrosion Deposit in Gap Between top of grout surface and bottom of 1/4" metal base Plate
- Friable Cementitious Grout and Micro-cracks in top of Cementitious Grout at Surface under Base Plate
- Small Unbonded Void (20 mils or 0.5 mm) Between top of grout surface and bottom of 1/4" metal base Plate
- Friable Cementitious Grout Debris at Void interface

The most important step in the process was to ensure that the existing anchor bolts penetrating the plate exceeded design capacity. If there were issues with strain creep or anchor-bolt slippage, the grouting would not compensate. To perform the inspection and repair, Structural drilled ½-inch-diameter holes using a grid pattern that was based on the approximate void locations. A borescope was placed down the drill holes

to determine the extent of the voids, particularly if they were in excess of ¾ inch. High-durometer silica sand was vacuum placed prior to resin injection in all suspected large air pockets. After the injection ports were installed and sealed, the epoxy was injected, and the process was repeated as necessary to complete the penetration of the entire skid. When the epoxy had cured, Structural performed acoustic emission testing on the steel skid base plate to ensure that all of the voids were filled.
