EXTERNAL POST-TENSIONING

Design Considerations
VSL External Tendons
Examples from Practice

VSL REPORT SERIES

PUBLISHED BY
VSL INTERNATIONAL LTD.

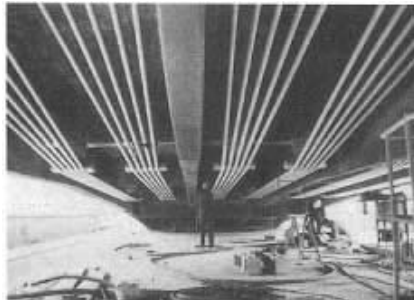
Figure 2: Bridge at Aue; external prestressed bars of the drop-in span

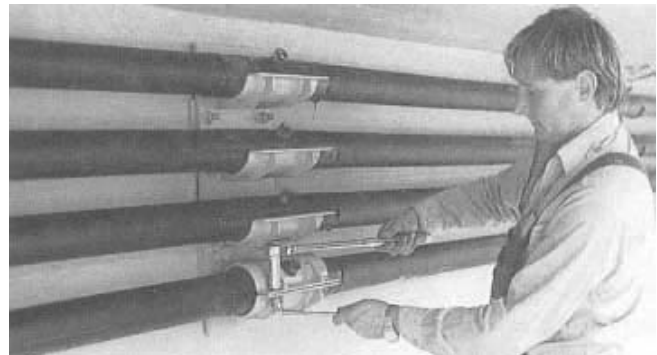
Figure 30: Intermediate tendon supports

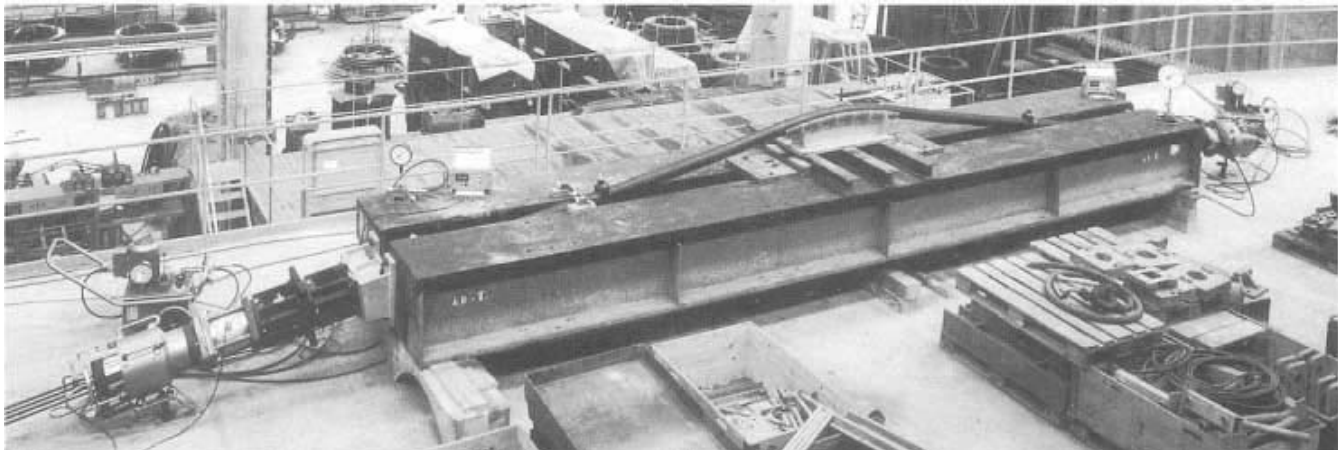
Figure 31: Test installation

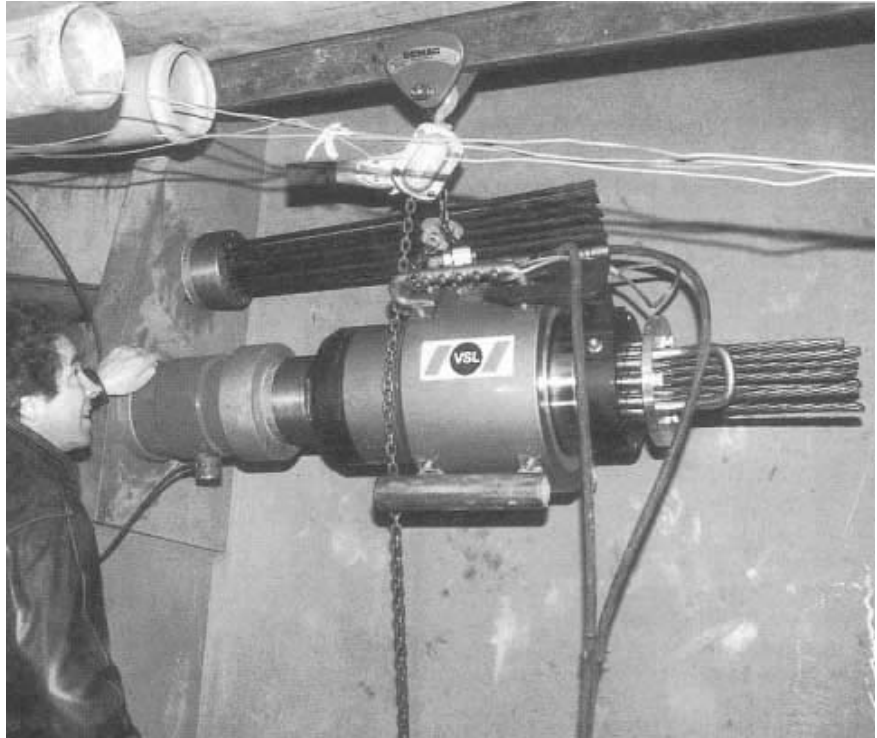
Figure 34 : Stressing of an external tendon equipped with a VSL Load Cell

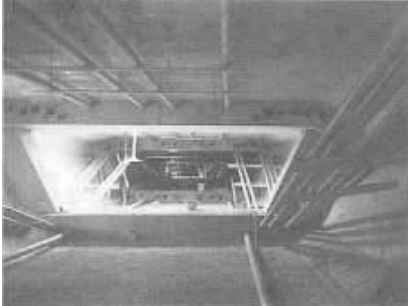
Figure 50: Tendons inside the box
