## Restoration of Coker Structures

Jaya Yerubandi, P.E.<sup>1</sup>; and O. S. Ali Ahmed, Ph.D., P.E.<sup>2</sup>

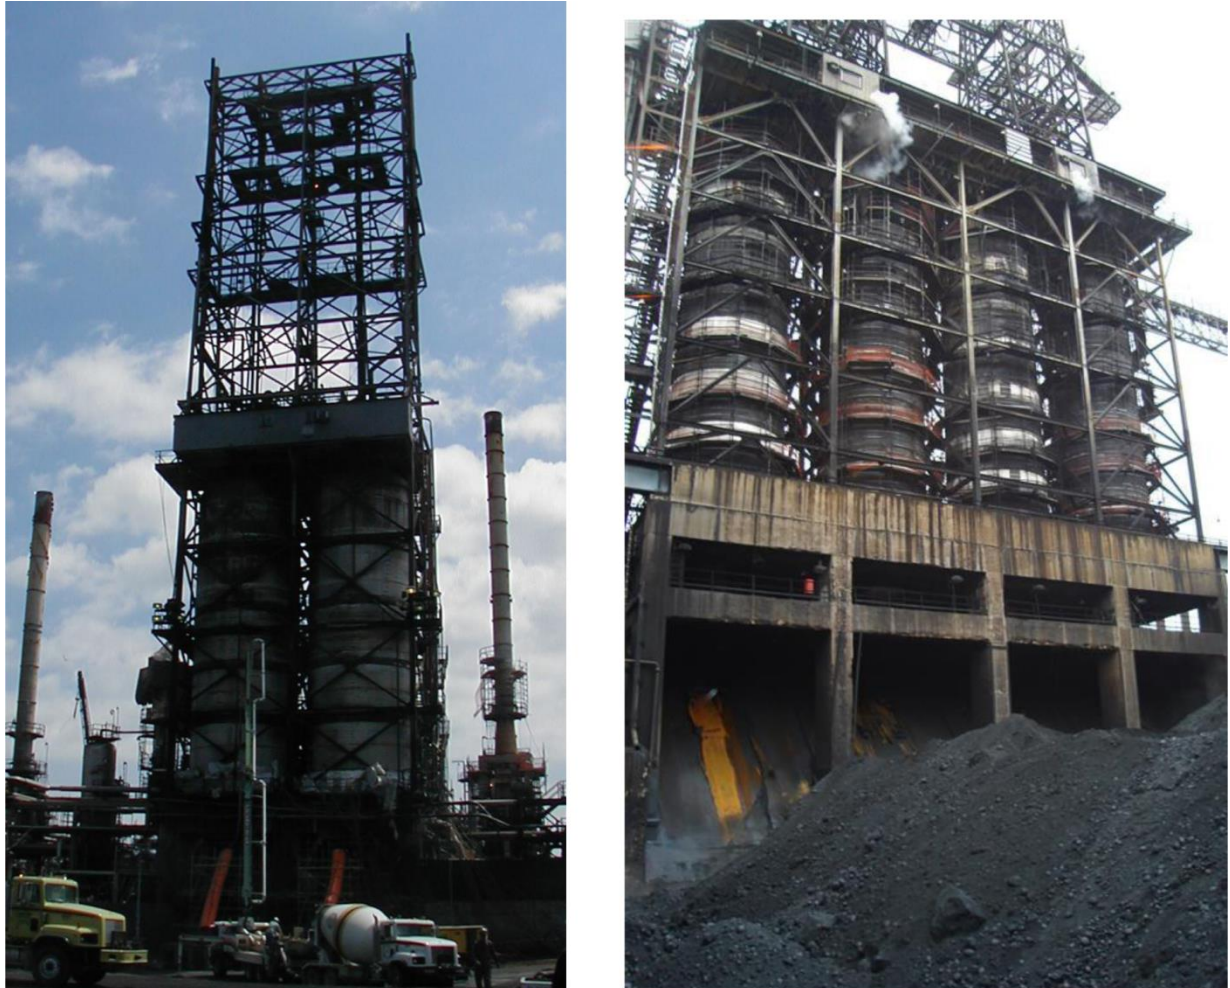
Figure 1 - Delayed Coking Units - Courtesy of Structural Group, Inc.

the coke drums work as a pair by alternating the coking and decoking process. As the decoking of an offline coke drum starts, the next coke drum is under operation which is filled up with the hot residuum through a switch valve. Alternating the coking between the drums make the coking a continuous process without halt. Therefore, it is typical to find Coker structures with two, four and eight coke drums operating continuously.

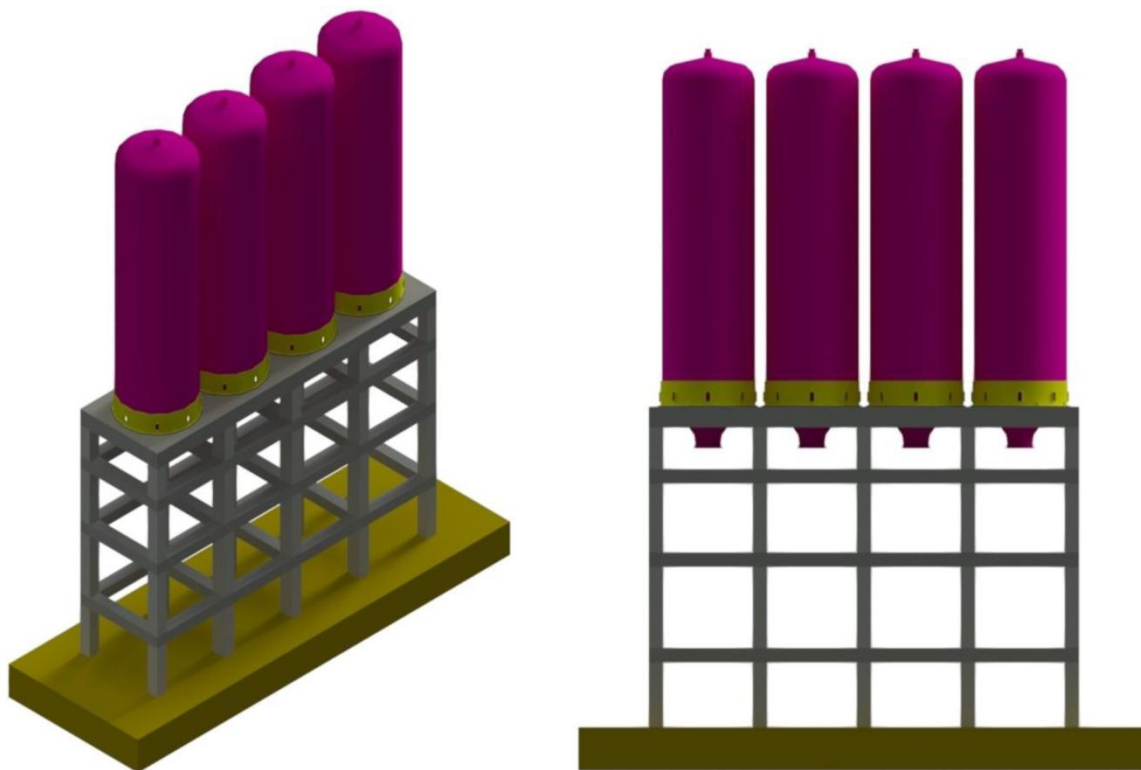
A Coker structure is a reinforced concrete construction in a refinery that supports multiple coke drums at an elevated platform called Table Top. The Table Top is a specialized concrete structure with octagonal penetration openings that are inscribed inside the circular base plate of the coke drum's skirt. Depending on the number drums, a table top has as many octagonal openings to support one coke drum per penetration. These octagonal penetrations are formed by a series of eight heavily reinforced concrete beams which are further supported on reinforced concrete columns down to the foundation. A coke drum is a tall cylindrical vessel made out of high chrome steel that typically measures 34m (110ft) in height and 8m (25ft) in diameter. The coke drum also includes a conical portion that extends up to 6m (20ft) at the bottom of the vessel through the octagonal penetration. The coke drums are attached to the concrete structure through

a skirt plate mechanism which is combination of a vertical plate that is welded to the outer circumference of the vessel and a base plate that is anchored to the concrete with embedded steel rods/bolts.

**Figure 2 – Isometric Layout and Elevation of a Coker Structure with 4 Coke Drums**

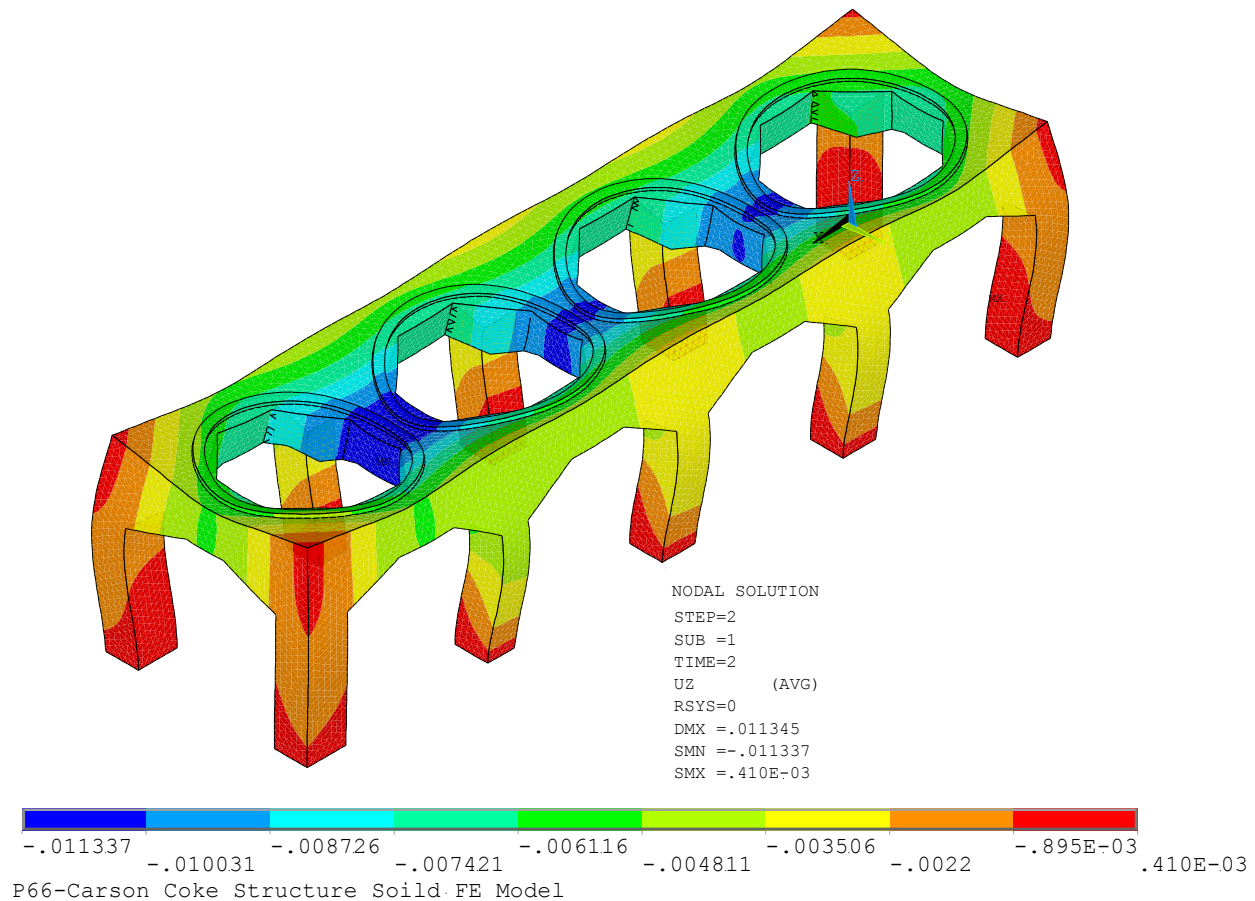
The operational dead loads of the coke drums (up to  $2.7 \times 10^6$ kg) are typically the controlling loads for the design stresses in the structural members of a Coker structure. When the coke drums are operations, constant loading (coking) and unloading (decoking) of adjacent drums takes place because of the drums working in pairs. Because of this scenario, the octagonal penetration beams supporting the coke drums are subjected to differential gravitational forces causing flexural, shear and torsional stresses especially the center beams. The center beams are subjected to forces from loads due to adjacent drums. The coke drum that receive hot sludge during decoking produce high heat ( $510^\circ\text{C}$ ) environment through the conical portion at the bottom of the coke drums, while the next coke drum under decoking process produces considerably low thermal atmosphere. Hence, the intermediate beams supporting the adjacent drums are exposed highly fluctuating thermal stresses across the reinforced concrete section.

Additional loads that are considered in the design of a Coker structure are the lateral loads due to wind & seismic effects and dynamic process loads occurring during loading and unloading of coke drums. Since the coke drums are tall and massive, the wind and seismic effects create heavy lateral loads in the form of base shear on the anchor bolts and a moment that causes tension and compression force couple on the end beams supporting the base ring.

**Figure 3 – Stress Distribution in Structural Members of Coker Structure**

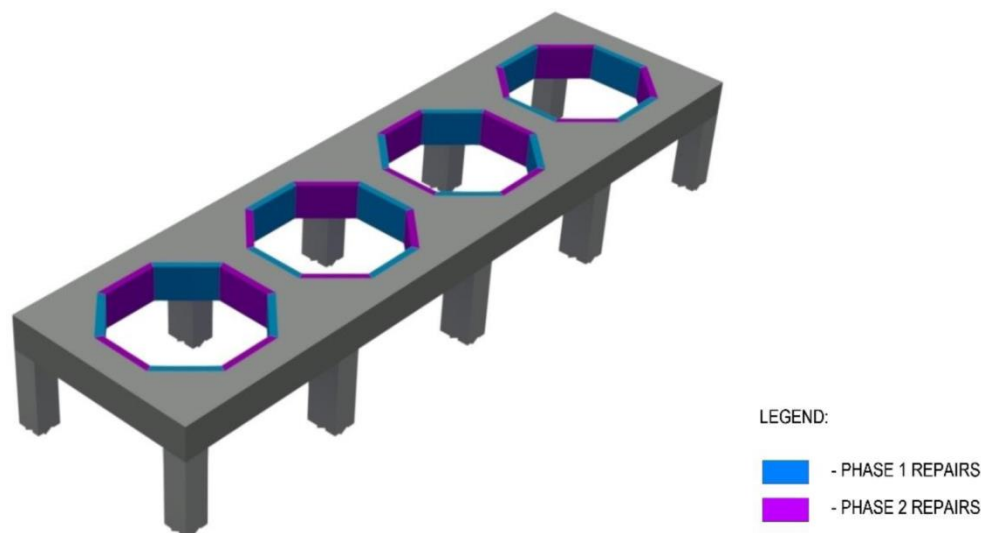
Delayed coking in a refinery is batch-continuous process, where the flow from the furnace to the coke drum under operation is nonstop. Therefore, to maintain the continuity of the coking process, the repairs on the octagonal penetration beams are performed with coke drums in place. Engineers review the data obtained from the condition assessment of the structure in order determine the critical structural members which may jeopardize the structural integrity. A phased repair approach is then evaluated based on the observed sectional losses the structural members have endured and possible temporary redistribution of forces among the other structural members for the loads transferred from the coke drums. The deteriorated sections are design checked in accordance with applicable building codes in order to assess the reserve structural capacity available while performing the repairs. One of the major factor that determines phasing of repairs is if the drums are in operating condition (drum filled with coke & water) or decoking condition (drum emptied) during repairs. A coke drum under its operating condition weighs almost 10 times its empty weight. Therefore, Coker structure repairs with coke drums online require more number of repair phases, meaning area of deteriorated concrete that can be repaired at one time will be less when compared to repairs performed while the drums are offline thus

increasing the construction time of repairs. Another factor to be considered in design of phasing is the turnaround time as the repair construction is required to be finished within the decoking time of the coke drum, so as to keep the coking process continuous.

**Figure 4 – Phasing of Coker Structure Octagonal Penetration Beam Repairs**

Multiple iterations are run to check the existing structural capacity of the deteriorated members to determine the most optimal phasing considering the process times and turnaround times. The design check is performed by reducing the cross section of the reinforced concrete beam along with the number of reinforcing bars that are exposed in the deteriorated portion of the beam. In the octagonal penetration, if four alternate beams are considered to be repaired in one phase, then the load distribution from the coke drum is assumed to be acting on the remaining four beams causing the load intensity to be doubled on the deteriorated sections of the beams. If the beams under investigation were designed conservatively in their as-built condition, meaning the capacity of the beams being much higher than required, the reserve capacity of the reduced section of the beam should be enough to sustain the high intensity of loads. If the reserve capacity of the deteriorated beams is found to be not enough to take the high intensity loads, then the alternate options of shoring the beams or performing the repairs while drums are offline or more number of repair phases while drums are online are considered.

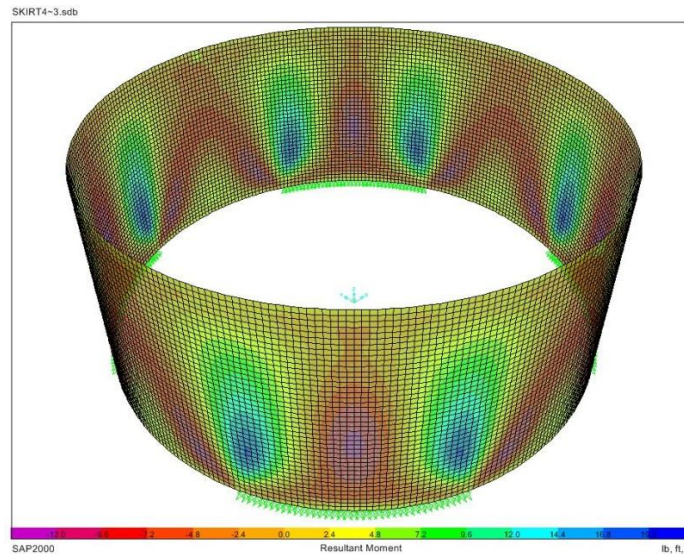
Additional investigations that are necessary for the design of phasing are the skirt base plate and effect of grout delamination. Delaminated grout that causes the tilting of the coke drum generates high flexural stresses on the base plate in the unsupported region between the ends of the deteriorated grout. In order to overcome these additional flexural stresses in the plates, the delaminated grout is replaced with steel shims that are sized to the transfer the bearing stresses between the base plate and concrete. Since, the concentration of the stresses is much higher and

is limited to the area of shim plate, the bearing strength of concrete is design checked. In cases, where drum tilting has occurred, the drums are repositioned by using hydraulic jacks that are placed between the skirt base plate and top of concrete to lift the drum. These jacks are operated by increasing pressure in low intervals, to make sure that the applied pressure is not greater than the tilted weight of the coke drum. The flexural stresses induced in the base plate due to loss of bearing also leads to warping of the vertical skirt plate.

**Figure 5 – Flexural Stresses in Skirt Plate due to Unsupported Base Plate**
