## Conquering Construction Challenges during PCCP Rehabilitation

M.P.Gipsov<sup>1</sup> and A.B.Pridmore<sup>2</sup>

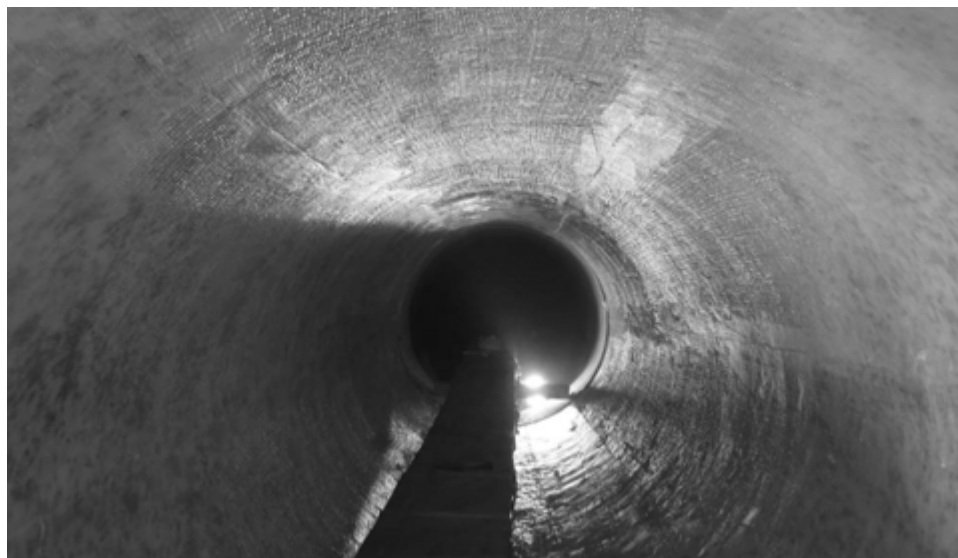
**Figure 2. Installed longitudinal layer of FRP**

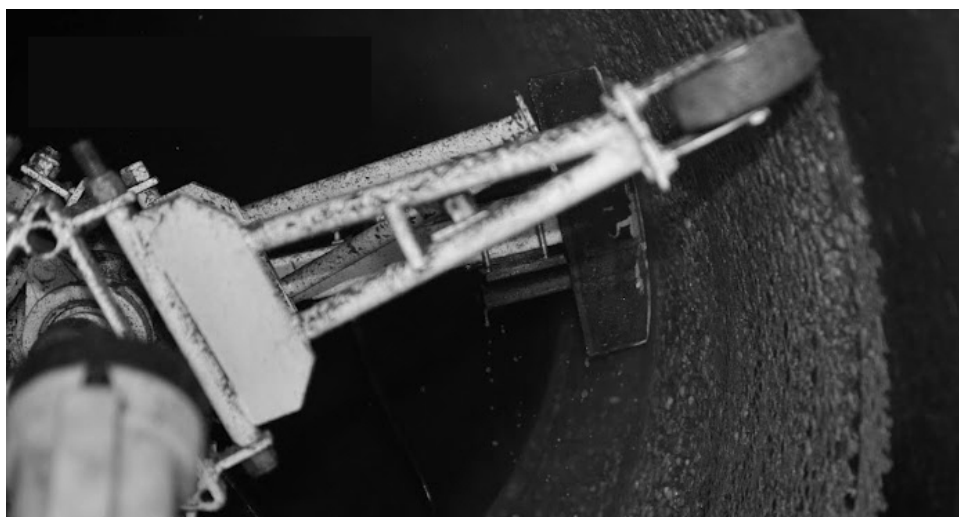
Figure 3. Surface preparation using water blasting equipment

Attempting to use lower pressure water blasting may result in low bond strength and could be a detriment to the long term integrity of the FRP system. Water blasting typically consists of hand-held or automated tooling, as shown in Figure 3, which positions the tip of the wand or wands 2-3 inches from the pipe surface. This type of equipment typically uses 6-10 gallons of water per minute, which is collected and managed as part of the installation process.

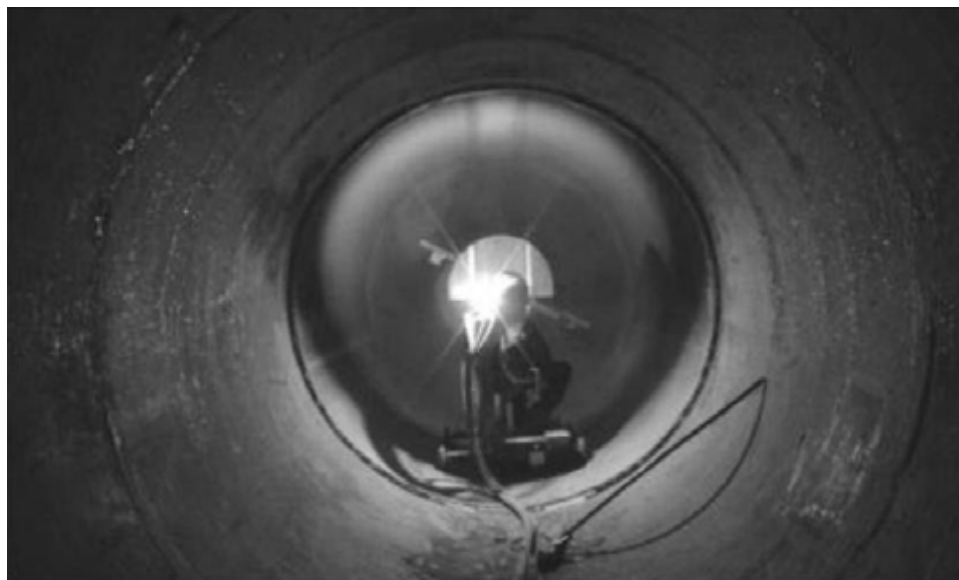
**Figure 5. Sponge-blast set-up on pipe interior**

A special type of abrasive blasting, which has displayed positive results for pipeline applications, is sponge-blasting. Sponge media is open-celled, water based polyurethane impregnated with abrasives and is applied to the substrate using hand held or automated equipment as shown in Figure 5. On impact with the surface, the sponge particles compress and slide across the substrate producing a scrubbing action, more similar to a sanding effect, but eliminating the harsher and dustier negative effects associated with conventional grit blasting. The abrasive media rebounds at relatively low velocity as the media converts the majority of its energy into work at the surface. The sponge blast media generates approximately 80 -90% less of the airborne dust levels normally experienced with conventional grit blasting media, allowing for improved safety during surface preparation.

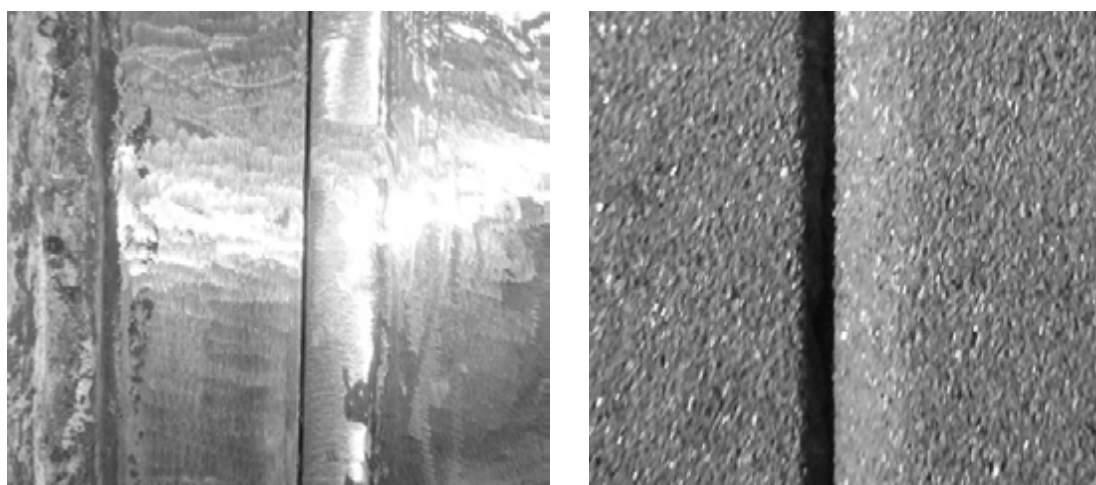
**Figure 8. Close up of prepared steel substrate in joint region of PCCP with grinder (left) and sponge blasting (right)**

Research and testing over the last several years confirmed the importance of the adequate preparation of the steel within the end termination region. Due to significant longitudinal forces applied on FRP liner, anchoring of the entire system is vital for the successful installation. Sufficient bond of the FRP liner material to the metal needs to provide adequate anchoring of the longitudinal layers to the end detail region and is necessary for ensuring leak tightness of the FRP system. Previous practices for preparation of the steel in the end termination regions for PCCP involved use of wire wheels or grinders to prepare the surface, as shown in Figure 8, left photo.

There has been additional research done which shows that grinding steel at joints is not sufficient in achieving the necessary adhesion between the FRP lining and the steel substrate. Near white metal, SP10, as shown on the right picture for

Figure 8 has been deemed as the industry requirement, which must be achieved through abrasive blasting. If water blasting was performed surface preparation for the main regions of the concrete substrate, abrasive blasting would still be necessary for the steel regions at the end termination locations. Due to safety concerns associated with grit blasting, sponge blasting has become the more prevalent abrasive blasting process due to less dust generated during construction.

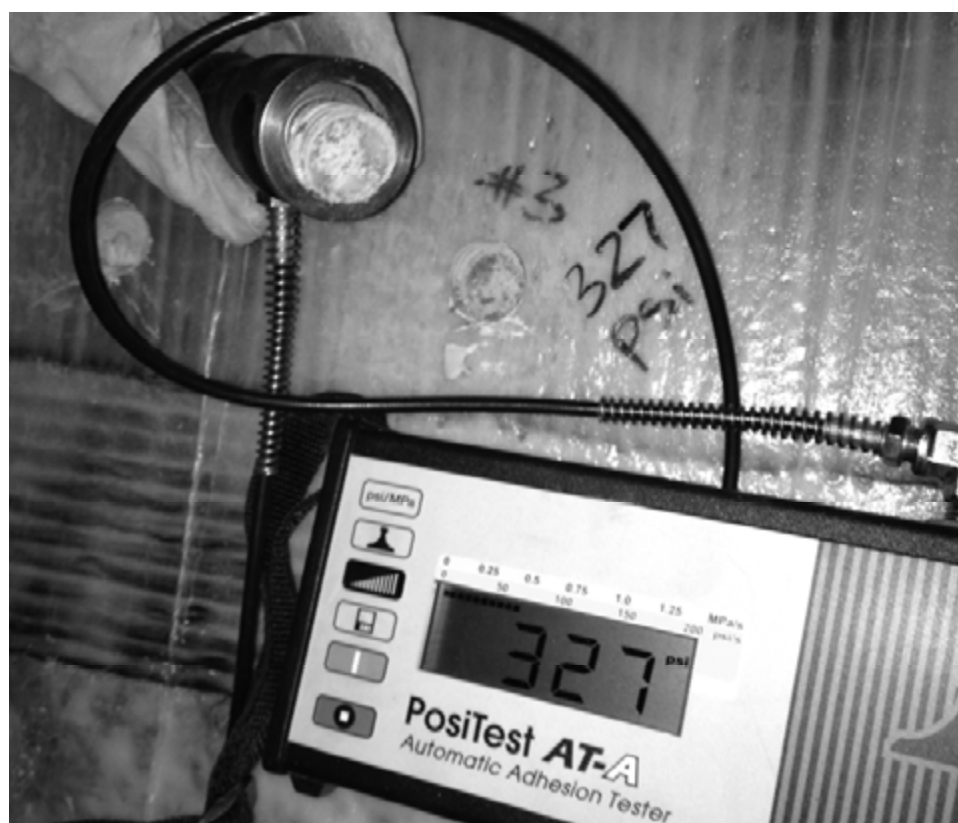
Figure 9. Adhesion test equipment used for ASTM D4541 test

On any construction project, discovery of unanticipated installation conditions causes challenges during construction. The key to successful projects is to anticipate challenges and to work on appropriate solutions. Therefore, among other QC tasks, installation of adhesion test panels and pull-off testing per ASTM D4541 is performed in order to confirm adequate preparation of the substrate as well as to obtain feedback regarding the condition of the existing inner core concrete. Figure 9 shows the adhesion test equipment used for the ASTM D4541 adhesion test.
