LOAD TEST EVALUATION OF FRP-STRENGTHENED STRUCTURES

Two case studies are presented in this paper that focuses on structural assessment of FRP strengthened members through load testing. In the first case study, load tests were used to confirm the performance of structural pan joist slab strengthened with externally bonded FRP in combination with a bonded concrete overlay. Load testing was also used to verify the performance floor joists strengthened for shear using FRP applied only to the sides of the joists. In the second case study, load tests were used to confirm the performance of composite structural floor system consisting of precast and cast-in-place structural elements. For all described cases, the full scale test confirmed the effectiveness of the externally bonded CFRP reinforcement and resulted in cost-effective strengthening solutions.

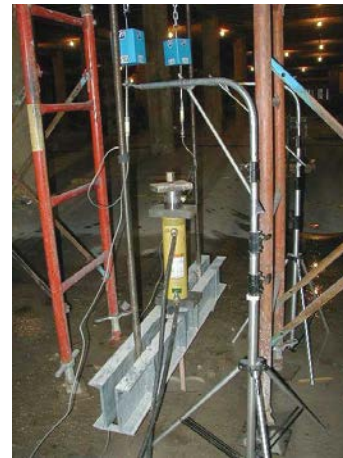
Fig. 1 – Test Setup

Analytical modeling of the joists indicated that the maximum moments and shear forces can be reproduced using two-point loads applied in the mid-span region, and spaced 6 ft (1830 mm) apart. The load was applied using hydraulic jacks that pulled against a reinforced concrete micro-pile that was installed on the ground floor below the second floor slab. A high strength steel bar was used to transfer the load from the jacks to the micro-pile. Linear variable differential transformers (LVDTs) were used to measure joists deflections at five locations along the span (see Fig. 1). A load cell was used to measure the applied load. All measurements were collected using a data acquisition system that allowed for real-time monitoring of the applied load and the behavior of the test joists. During the test, deflections and crack width were monitored for stability.

The cyclic load tests were designed to locally verify the performance of some typical joists that appeared to be the “weakest link.” To this end, the joists were loaded near their ultimate strength and their response was measured in terms of deformation and crack width. The cyclic load testing procedure involved applying concentrated loads to the test joists at predetermined locations to simulate the effect of maximum flexural forces at mid span and maximum flexural as well as maximum shear forces at the supports of the joists.

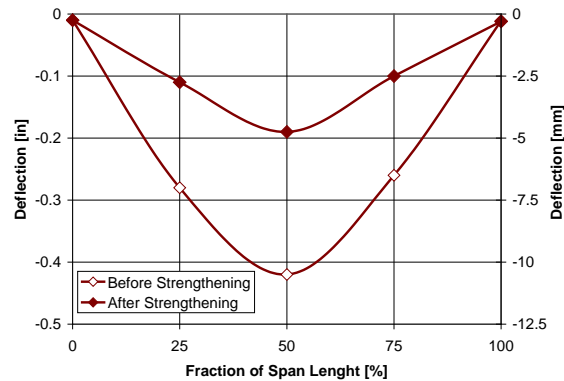
Fig. 3 – Performance of the Structure Before and After Strengthening

Results of the second load test demonstrated the improved strength and stiffness of the joists after strengthening (see Fig. 3). Based on the test results, the strengthened joists were rated for the self-weight plus 36 psf (1.7 kPa) super-imposed dead load (RC overlay) and 150 psf (7.2 kPa) live load.

Results of the first test indicated that failure of the joist was governed by yielding of top reinforcement at the support. No failure signs were observed at the mid-span region. Based on the test results, the joist was rated for a super-imposed dead load of 25 psf (1.2 kPa) plus a live load capacity of 135 psf (6.5 kPa). The shear performance was adequate with no shear cracks or failure signs observed.

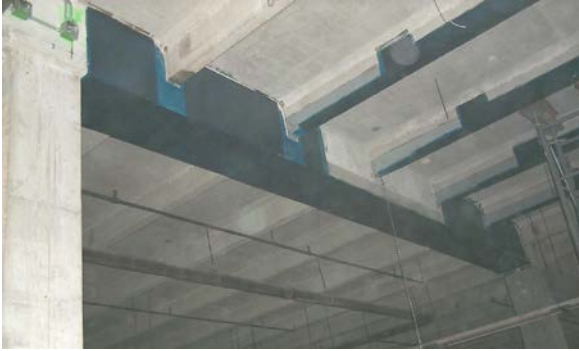
Fig. 4 – Structural Strengthening

The installed strengthening system consisted of multiple plies of CFRP sheets attached to joist's soffit to increase their positive bending moment capacity. CFRP strips were also wrapped around the joists' stem at each end to provide anchorage against peeling. The beams were strengthened using FRP to improve their positive and negative moment capacity. For positive moments, CFRP strips were installed on the soffit of the beam along the entire beam span. The required amount of CFRP for negative moments was equally divided and installed on each side of the column, in the direction of the beam. For shear, CFRP strips were U-wrapped around the beam for approximately 1/3 span at each end (See Fig. 4).

Strengthened beam and joists

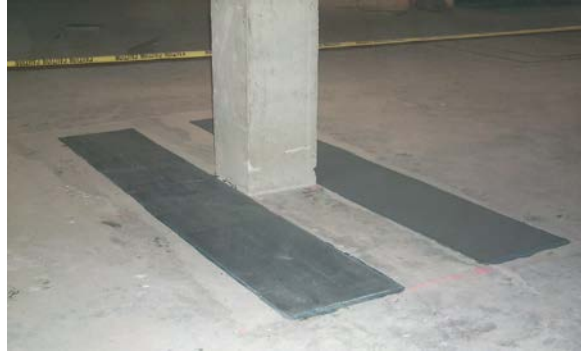
CFRP layout for negative moment strengthening

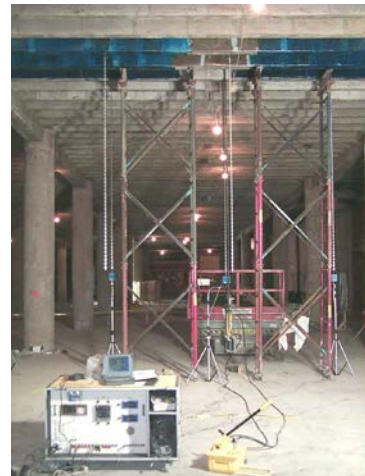
Fig. 5 – Pull-Down Test Procedure

The load test configuration was a pull-type test in which the hydraulic jack pulled against a reinforced concrete micro-pile cast into the ground on the level below (See Fig. 5). Based on the test results it was concluded that the slab had sufficient capacity to resist the new design loads. As such, no strengthening was required for the slab.

Due to novel use of FRP for this type of construction, the local building officials required that cyclic load tests be conducted to confirm the load rating of the existing structure and to assess the performance of the technology. The objective was to test the performance of the structural components of the floor system (slab, joist, and beam) using point loads applied at the mid-span region. To this end, 5 cyclic in-situ load tests were performed on the floor system, 3 before strengthening and 2 after FRP strengthening. The aim of the first test, TEST 1, was to verify the positive moment capacity of the existing one-way slab between the joists. TEST 2 was used to verify the positive moment capacity of the typical joist. TEST 3 was used to verify the positive moment strength of the typical beam. Two tests were conducted after strengthening: TEST 4 was conducted on FRP strengthened joists and TEST 5 was conducted on a FRP strengthened beam. Each test consisted of 6 loading-unloading cycles followed by a 24-hour test conducted in accordance to Chapter 20 of ACI 318. For all load tests, the critical test section was at the mid-span of the test member. The structural elements were loaded until the desired moment at the critical section was produced or inelastic behavior was observed.
