Hope Creek Circulating Water Pipeline 2013 Carbon Fiber Upgrade

Corporate Program Manager- Engineering Services, Piping
PSEG Nuclear Salem and Hope Creek Generating Stations
James.melchionna@pseg.com

Vice President- Pipeline Solutions
STRUCTURAL TECHNOLOGIES
apridmore@structural.net
714-869-8824

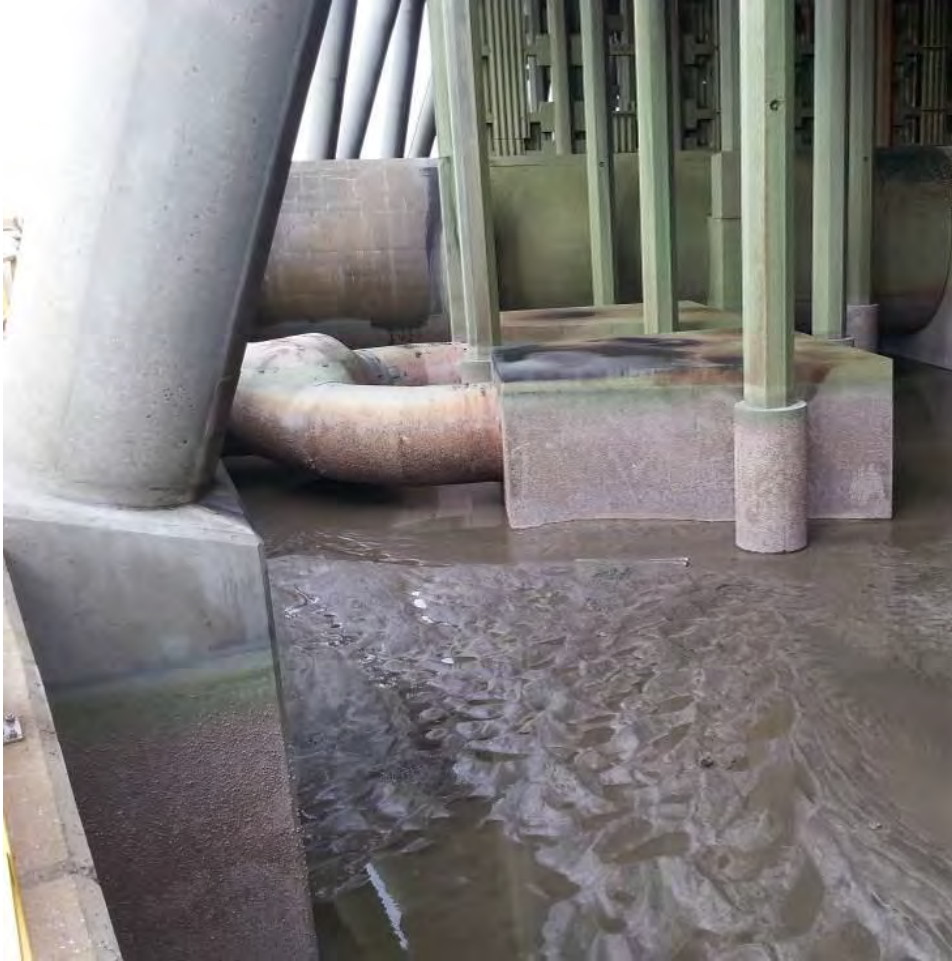
- Cooling water tower basin filled with muck
- De-mucking required prior to access into the pipeline
- Quantity of muck unknown prior to start of outage
- Specialty scaffolding required to bring materials and personnel from staging area into basin

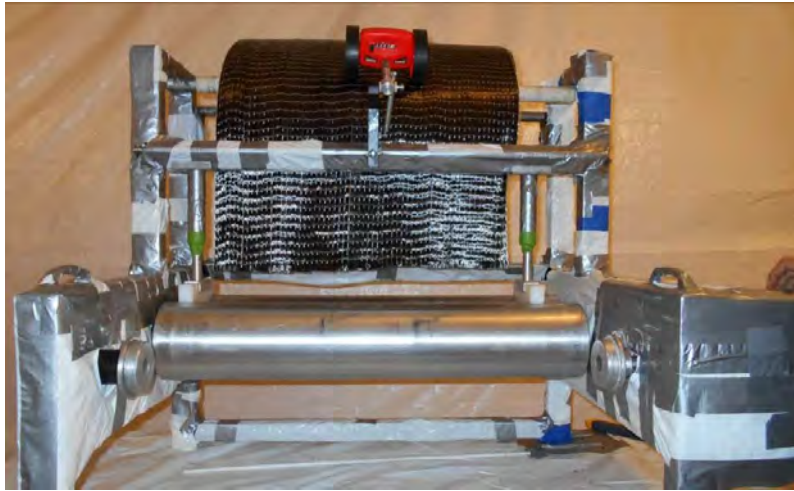
- Lot numbers of fabrics and epoxies are documented
- Gap between saturator rollers measured and calibrated using weigh test
- Weigh test verifies ratio of fabric to epoxy is within tolerance (1:1 for carbon fiber fabric, 0.8:1 for glass fiber fabric $\pm 10\%$)

- Materials arrive on site in premeasured containers for part A and B components
- Designated mixing region is an isolated area to avoid material contamination
- Mechanical saturator ensures consistent application of epoxy to carbon fiber

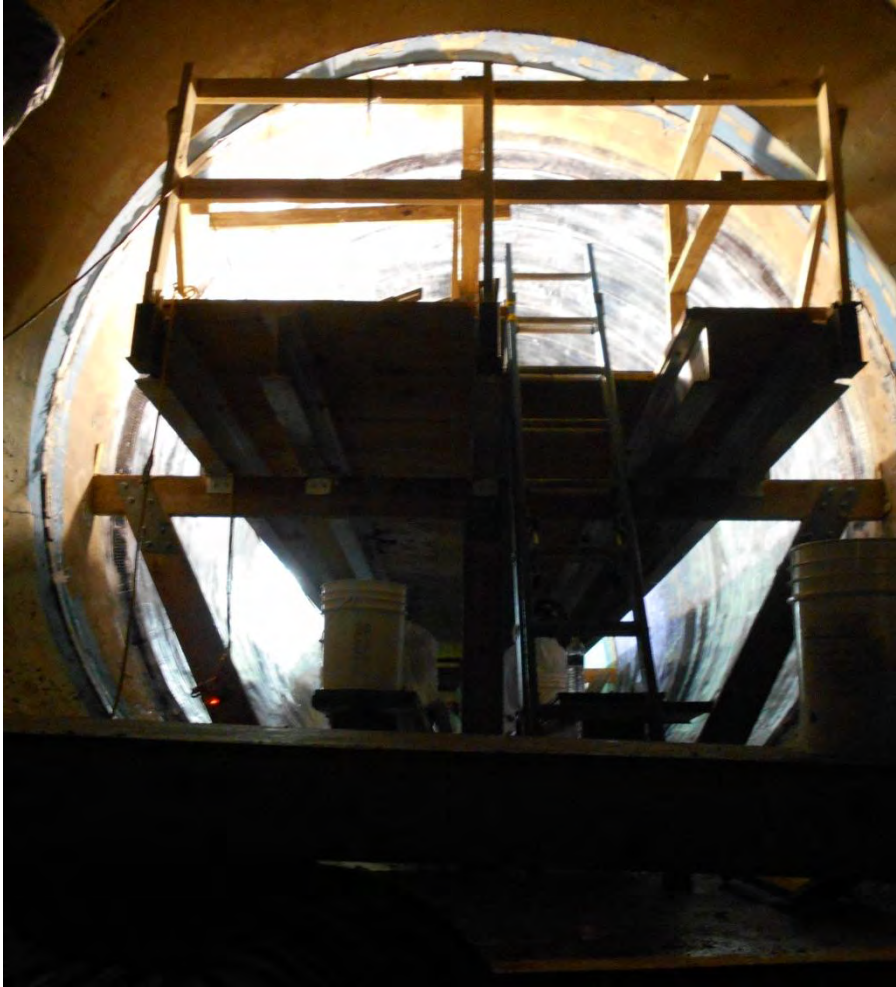
- Live load of 25 psf
- 30 ft spans
- Changes in vertical slope midway through span
- Specialty connection designs required by PSEG safety dept
- All materials required to fit through limited access into the pipes

Project required custom built two-tiered engineered scaffold for the following requirements:

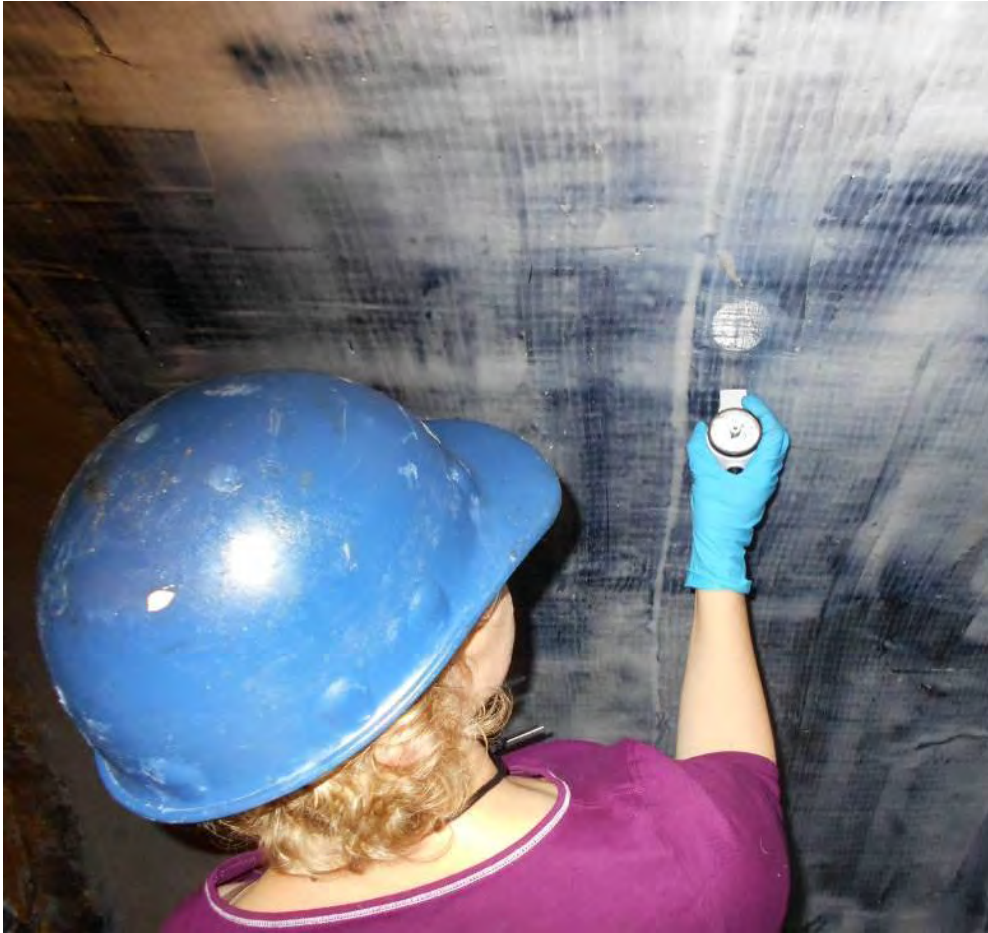
- Air temperature, surface temperature, and humidity during CFRP cure recorded
- Shore D hardness values throughout pipe recorded to document progression of cure
- Degree of cure testing performed to verify degree of cure achieved for CFRP system

- After top coat is installed, final cure of CFRP system is performed at elevated temperature

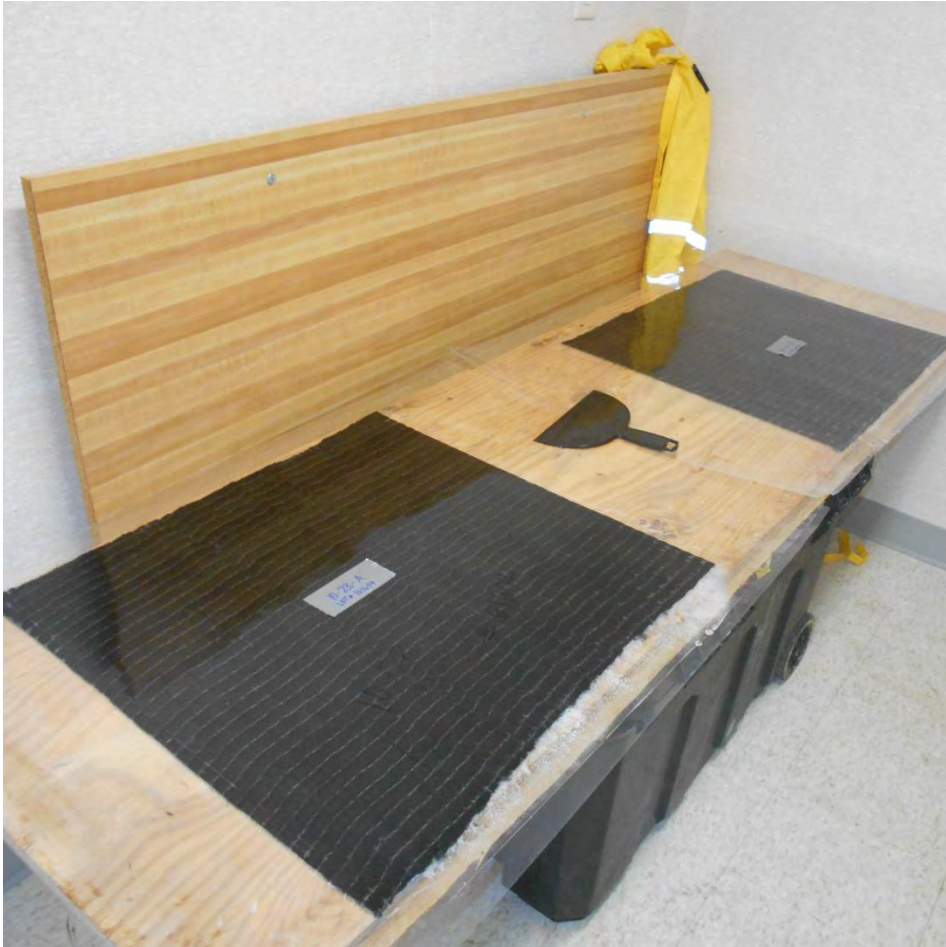
- Air temperature and humidity during CFRP test panel fabrication are recorded
- Lot numbers for carbon fiber fabric documented
- Once panels cure, they are sent off to 3rd party test facility for tensile tests per ASTM D3039

- During each shift of CFRP installation, two test panels are fabricated
