# TIMBER PILE REPAIR & STRENGTHENING SYSTEMS: V-Wrap™ GFRP Timber Pile Restoration System

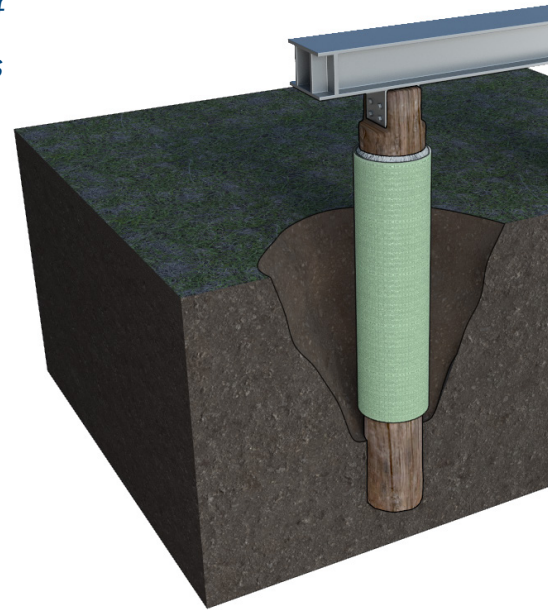
STRUCTURAL TECHNOLOGIES' V-Wrap™ Timber Pile Restoration Systems combine lightweight, high-strength glass fibers bonded with adhesive resins to a formed concrete jacket to restore deteriorated timber piles structural capacity and provide long-term protection.

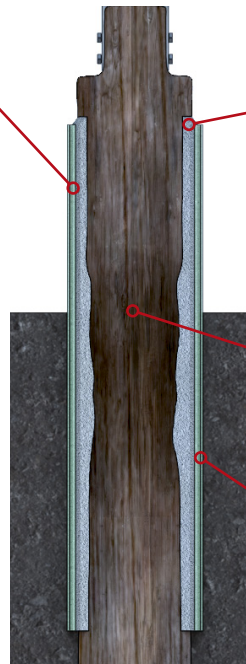
V-Wrap EG50 is a unidirectional glass fiber fabric with fiber oriented in the 0° direction and additional yellow glass cross fibers at the 90°. V-Wrap EG50 system is field laminated using

environmentally friendly, two-part 100% solids and high strength structural adhesives to form a glass fiber reinforced polymer (GFRP) system used to reinforce structural elements.
