Dominion Energy's Surry Power Station.

Surry's safety-related pipeline upgrade

A seven-year project to renew safety-related piping picks up an industry award as it prepares Surry for long-term operation.

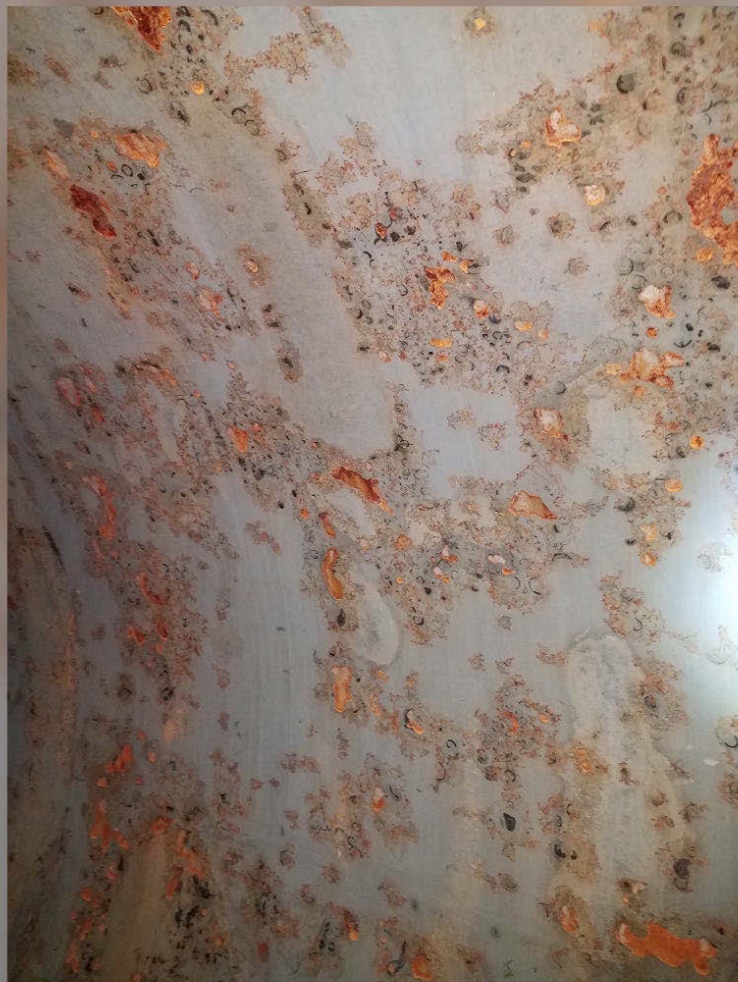
The condition of Surry's metallic pipelines required routine repair work, driving the desire for a long-term CFRP upgrade.

Over the past several years, routine inspections required by American Society of Mechanical Engineers (ASME) Boiler & Pressure Vessel Code (B&PVC) Section XI, "In-Service Inspections of Nuclear Power Plant Components," identified significant corrosion on the interior surfaces of the circulating water and service water carbon steel piping. During refueling outages, this piping has been routinely drained, cleaned, inspected, welded, and coated with a ceramic-epoxy coating system. These maintenance activities have proved very costly and have often impacted the refueling outage critical path. Meanwhile, the overall condition of the carbon steel piping has continued to degrade, increasing the possibility of an unplanned outage. After many years of addressing pipe degradation during every outage, Surry needed to find a long-term solution for the affected pipelines.

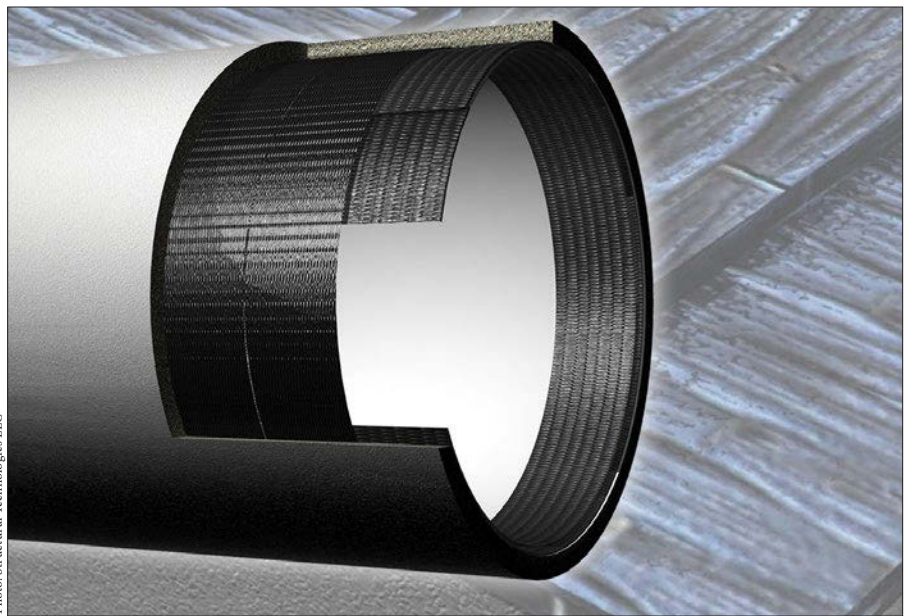
Structural Technologies' V-Wrap CFRP System received approval from the NRC for an upgrade of safety-related pipelines at Surry.

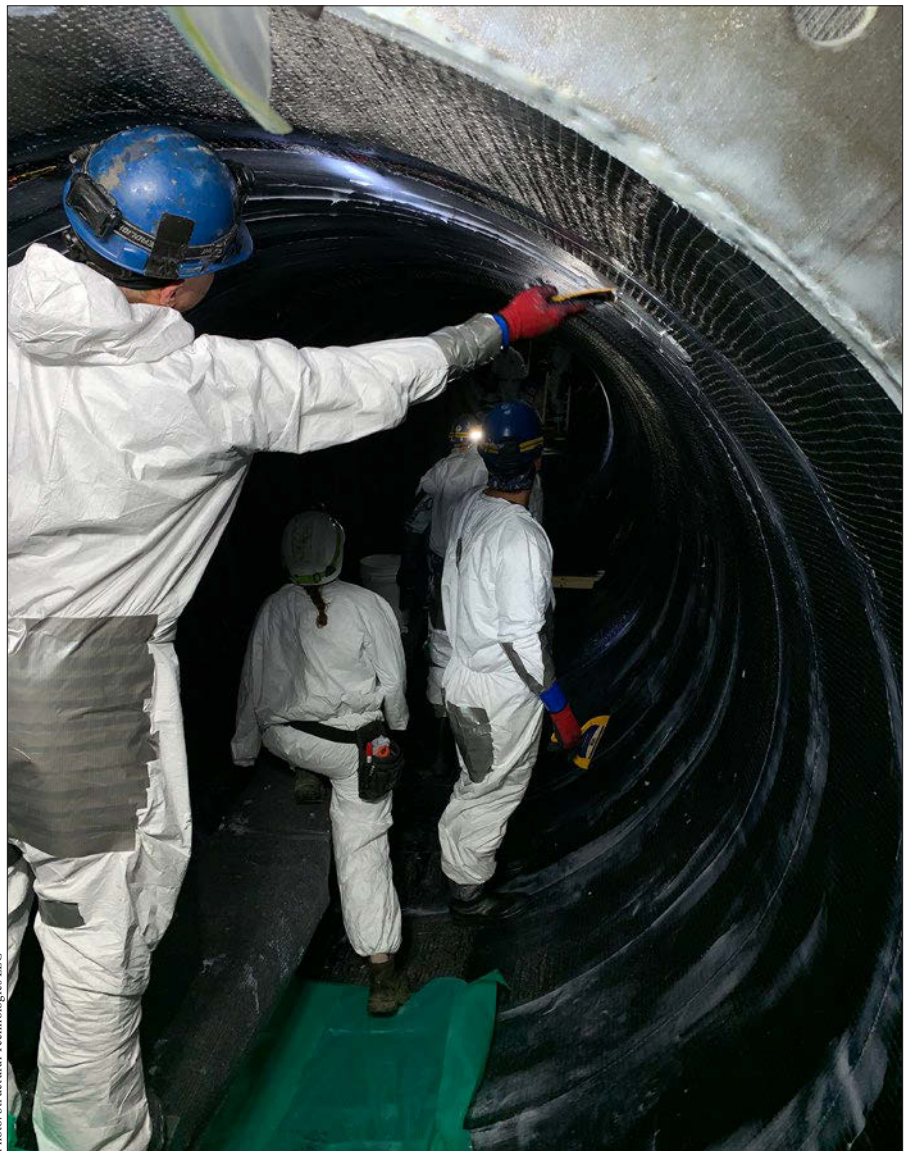
Quality control inspections were ongoing during the CFRP installation process as part of the pipeline upgrade.

Verification of the installation process consisted of a series of tests conducted throughout the installation phase, including saturator roller calibration, a weight ratio test to verify epoxy saturation, testing of the bond and the tensile strength of the CFRP, and cure testing to verify that the CFRP system is fully cured prior to placing the piping back into service.

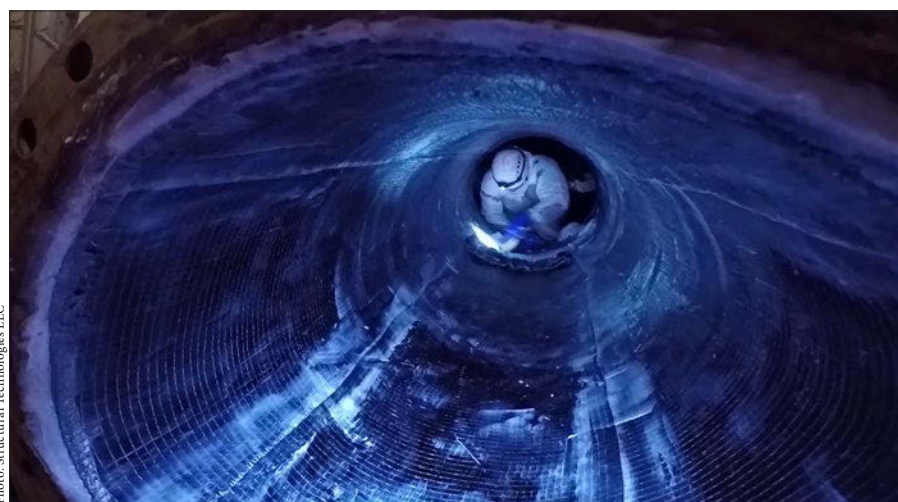
A trained and certified technician, meeting Surry specification requirements, installs the CFRP system in a 30-inch segment of piping.

The saturated CFRP is applied to the inside surface of the host pipe in what is called a “wet lay-up process.” The fabric, fully saturated with epoxy, is pressed to the inside surface of the host pipe to achieve intimate contact. Any air trapped between layers is released or rolled out without wrinkling of the carbon fiber. The installed CFRP is oriented in the directions indicated on the design drawings, with no greater than a five-degree misalignment of the fabrics allowed from the specified direction.

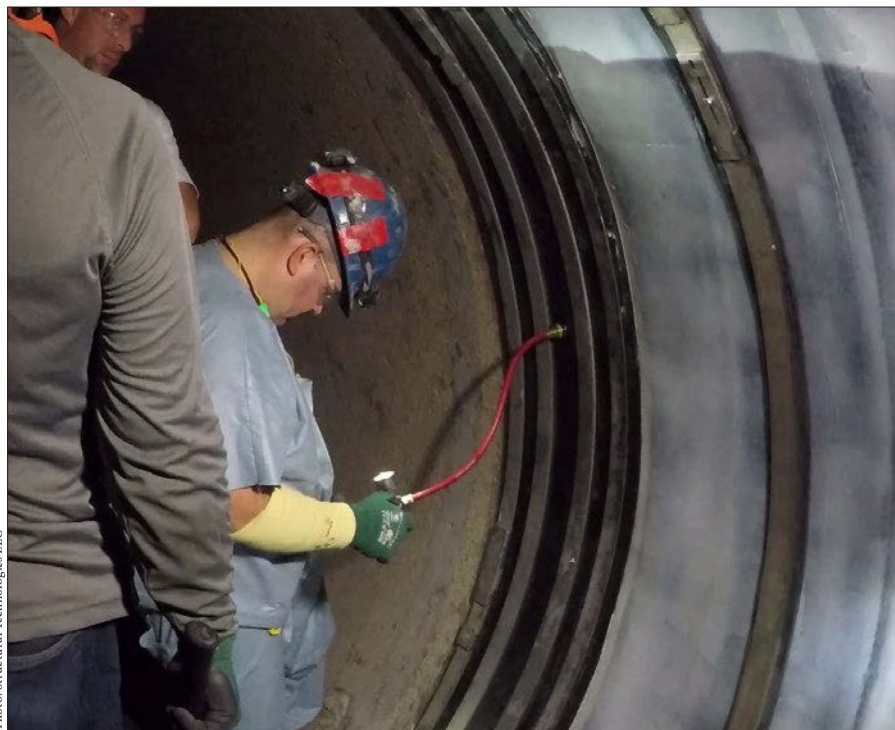
Custom-designed termination points are critical to the long-term performance of the CFRP lining system.

Following the installation of the CFRP system at Surry, the termination points were installed. The termination points of the CFRP liner are a critical point of the lining system, and they are designed so internal water pressure is not able to migrate behind the CFRP system. If the CFRP is not properly sealed at termination points and pressure is allowed to build up behind the liner, the CFRP lining will be structurally ineffective. In addition, a topcoat of thickened epoxy is added as the final layer across the entire installed CFRP system. Following these steps, the CFRP system is cured and the installation is complete, following quality control (QC) sign-off.

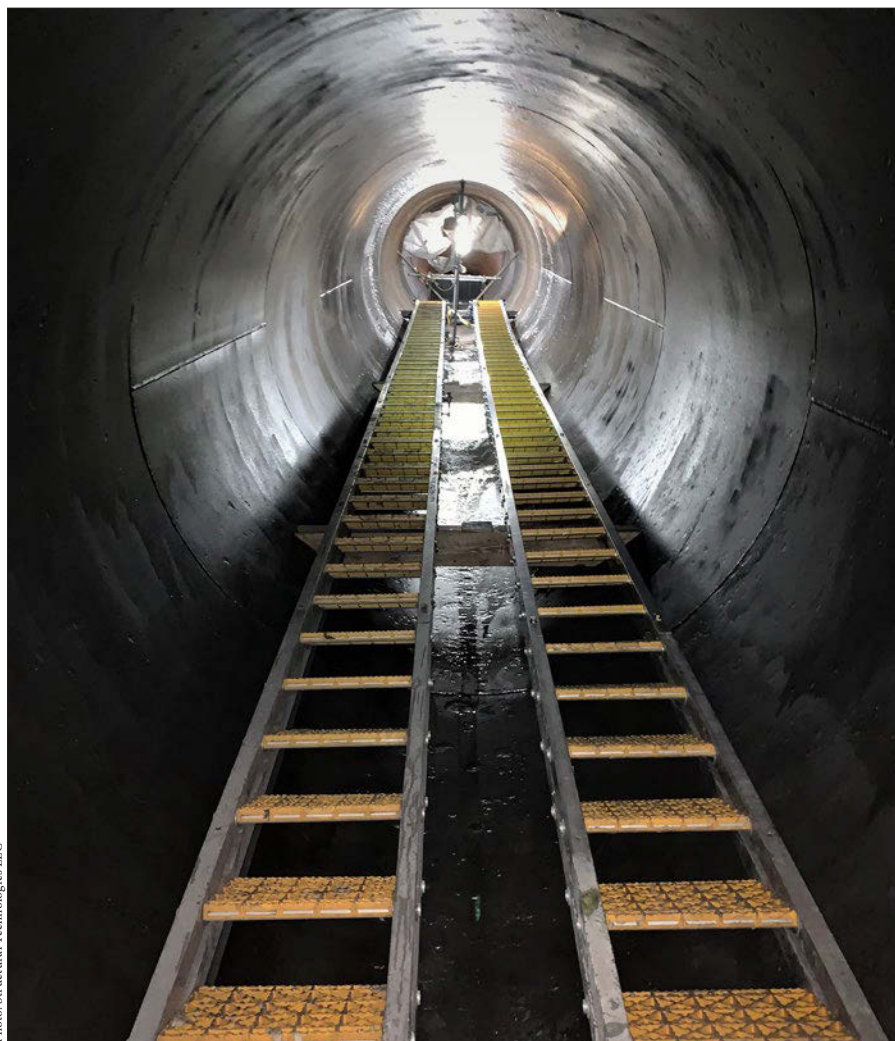
Specialized access systems were required for safety during the CFRP upgrade of sloped pipe segments.

is staged to avoid contact with the material until it has cured, which takes about 72 hours in ambient temperatures. In the 96-inch piping upgraded at Surry, a temporary platform was installed to allow for continued access and completion of the CFRP installation process.
