Fifteen Years of Lessons Learned: Design and Construction of CFRP Liners for Large Diameter Pipelines

A.B. Pridmore¹, R. Ojdrovic², and M. Geraghty³

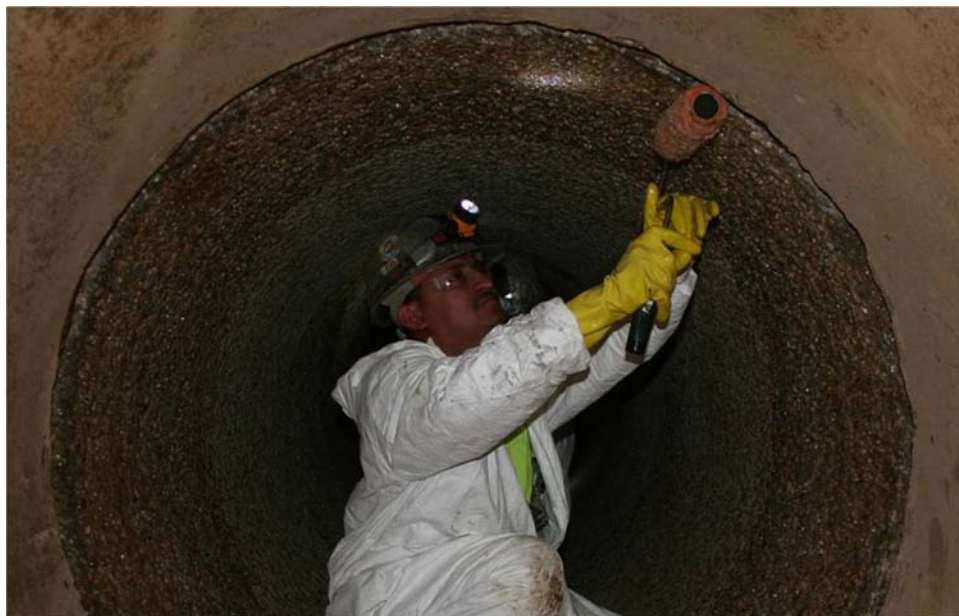
Figure 1. Application of epoxy primer

A typical CFRP lining system consists of a primer, thickened epoxy, epoxy, reinforcing fabric, and top coat. The most effective epoxy systems for long-term civil infrastructure rehabilitation applications, such as rehabilitation of PCCP lines, are ambient cure thermoset epoxy systems. In order to minimize environmental hazards present inside the pipeline during application of the materials, epoxy systems which are made of 100% solids and are Volatile Organic Compound (VOC) compliant are utilized. The primer layer of epoxy applied to the pipe consists of a low viscosity epoxy as shown in Figure 1 which penetrates into the concrete substrate, providing an adhesive bond for the thickened epoxy and saturating layers as well as subsequent layers of the CFRP system. The thickened epoxy system is made up of either a specially formulated higher viscosity epoxy system or made up of the saturating epoxy and silica fume which have been mixed together in accordance with the manufacturer's recommended procedure. The thickened epoxy filler is used to even out the concrete substrate, fill voids and it is also used in between layers of CFRP to ensure intimate contact of the CFRP system at all locations within the CFRP liner.

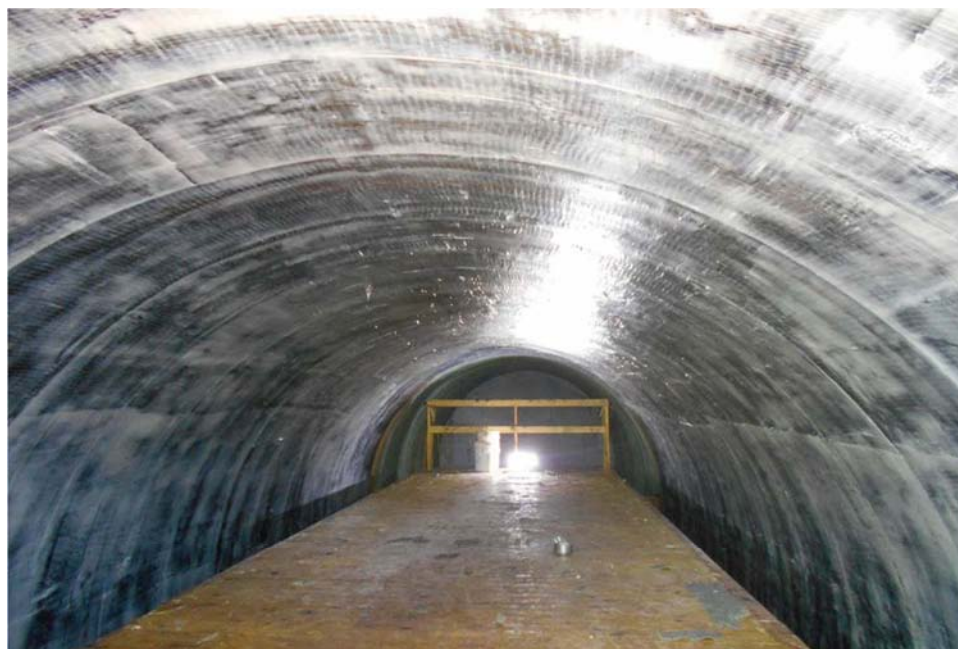
Figure 2. Completed CFRP lined section prior to removal of scaffolding

CFRP repair of degraded PCCP is designed to provide strength, durability, and reliability throughout the service life of the repaired pipe when the pipeline is subjected to long-term and short-term loads. The CFRP system, as shown in Figure 2 is to have adequate reliability such that the probability of failure of the repaired pipe resulting from the variations of loads and resistance is similar to the probability of failure associated with the use of more traditional structural repair materials or pipeline replacement.

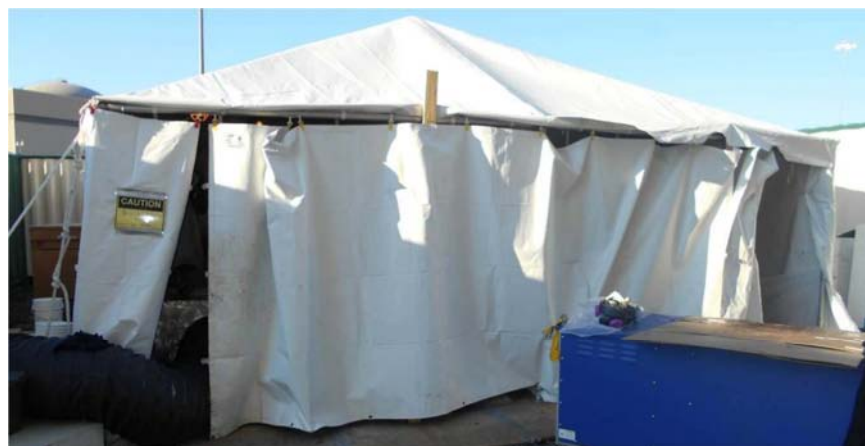
Figure 3. Typical enclosed material mixing area

necessary, lay-down areas, and saturation and material mixing areas; and have all required materials and equipment staged at the pipeline work locations. A typical enclosed mixing area is shown below, in Figure 3. The mixing and storage areas for materials must be maintained at a minimum temperature of 40F.

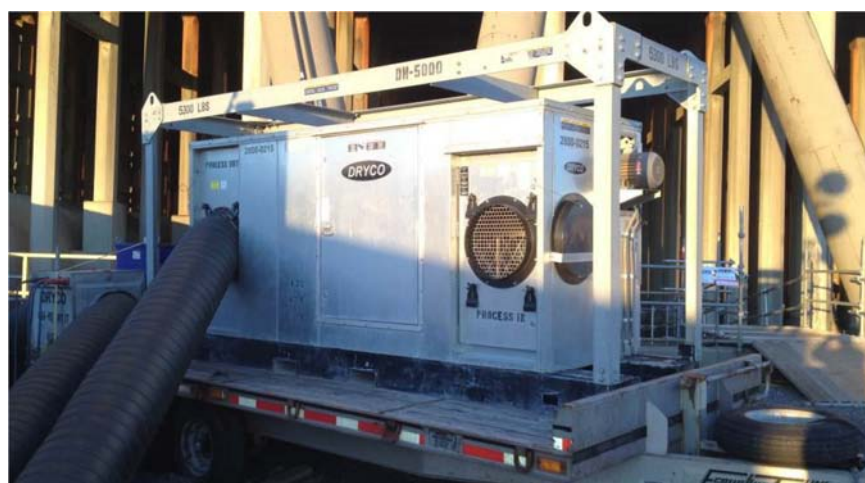
Figure 4. Dehumidification unit

Safety is an important aspect of these projects, given that the work takes place in a confined space with limited access and egress availability. Ensuring that crews within the pipe have adequate air supply is one portion of the safety approach. Dehumidification air-blowing units are installed at the appropriate locations, as shown in Figure 4, to ensure a constant supply of clean dry air for ventilation purposes and also to assist in drying the segments to be strengthened following the surface preparation operation.

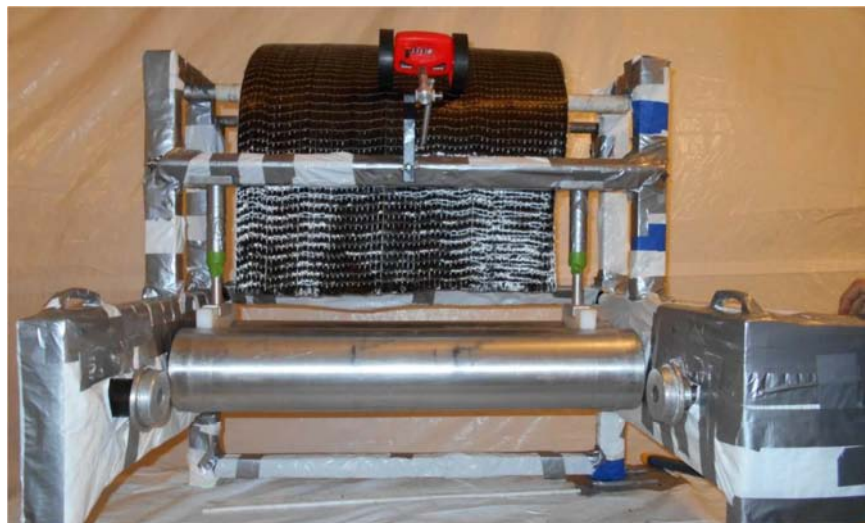
Figure 5. Mechanical saturator

the saturated sheets into the pipe for technician installation. Saturation takes place using specialized mechanical saturation equipment, as shown in Figure 5. Fabric saturation is a critical step in the process and it should be even though the fabric thickness such that there are no dry fabric spots.

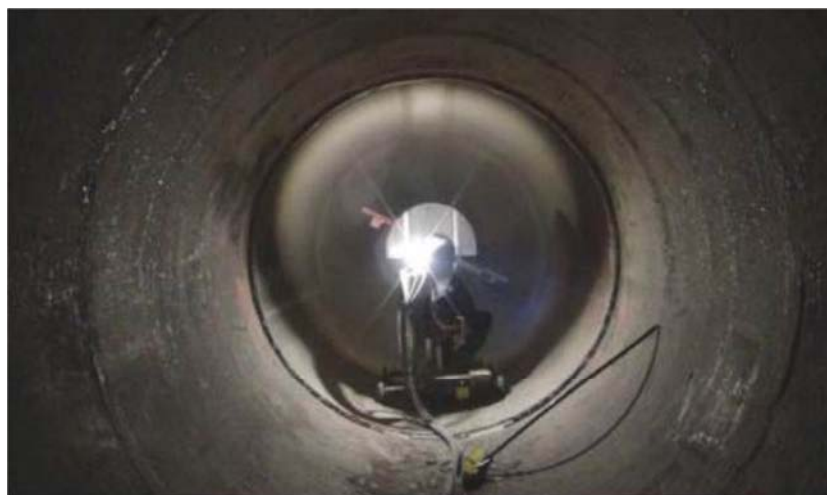
Figure 6. Sponge-blast set-up on pipe interior

Surface preparation can be performed by ultra-high pressure water blasting, abrasive blasting or pneumatic sponge-blasting. If water blasting is selected, it is recommended that 40,000 PSI equipment, operating at 30,000 to 36,000 PSI is utilized to ensure proper profile of the concrete substrate is accomplished. Use of low pressure may result in inadequate surface preparation and low bond strength. Abrasive blasting is another effective method for surface preparation and standard techniques apply, to the specified surface profile. Special precautions regarding mitigating airborne particulate levels are taken for this type of blasting in a confined space. An alternative method of abrasive blasting with environmental benefit is sponge-blasting, as shown in Figure 6. Sponge media is open-celled, water-based polyurethane impregnated with abrasives.

On impact with the surface, the sponge particles compress and slide across the surface producing a scrubbing action, more similar to a sanding effect, but eliminating the harsher and dusty negative effects associated with conventional grit blasting. The abrasive particles achieve the desired surface profile and the media rebounds at quite low velocity as the media converts the majority of its energy into work at the surface. The sponge blast media generates less than 10% of the airborne dust levels normally experienced with conventional grit blasting medias, allowing for improved safety during surface preparation.

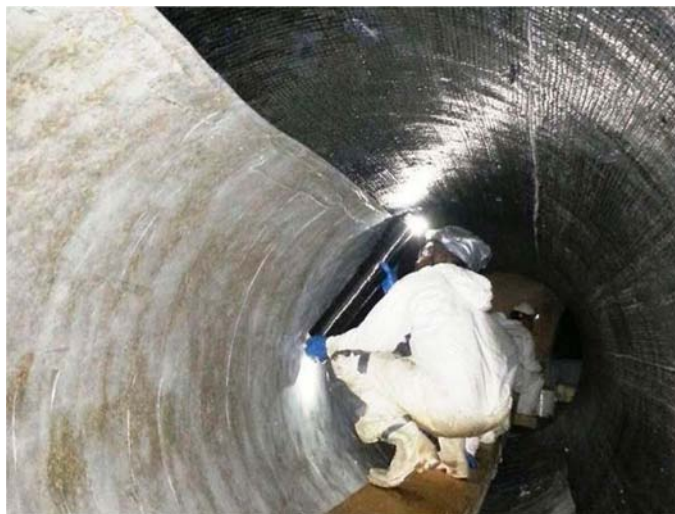
Figure 7. Installation of longitudinal layer of CFRP

The saturated carbon fiber is applied to the inside surface of host pipe in a wet lay-up process. Dry layup process should not be used as it may result in unsaturated fabric and debonding. The wet-out fabric is pressed to the inside surface of the host pipe to achieve intimate contact. Any entrapped air between layers is released or rolled out without wrinkling of carbon fibers. Figure 7 below shows the first layer of longitudinally applied CFRP being installed inside the pipeline.

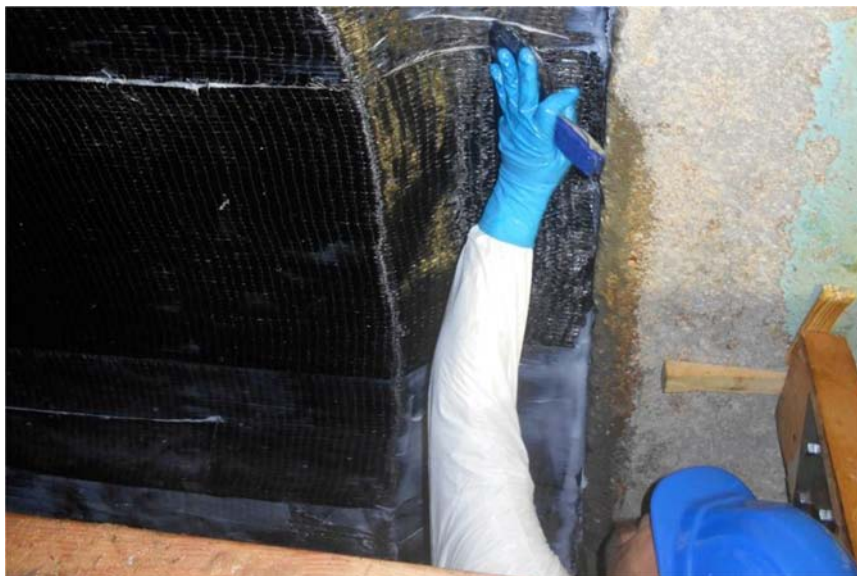
Figure 8. Completed termination detail

The length of the bond between CFRP laminate and the steel substrate in the joints is designed so that the maximum axial force in the CFRP in the longitudinal direction from all loading conditions will not cause shear bond failure or tension failure. To prevent galvanic corrosion, the CFRP is constructed on GFRP applied to steel surface. The procedure used for preparation of termination detail must avoid damage to the steel cylinder. Any damage, including gouges and punctures, needs to be repaired prior to CFRP system installation. Installation of the CFRP system into the joint region is shown in Figure 8.

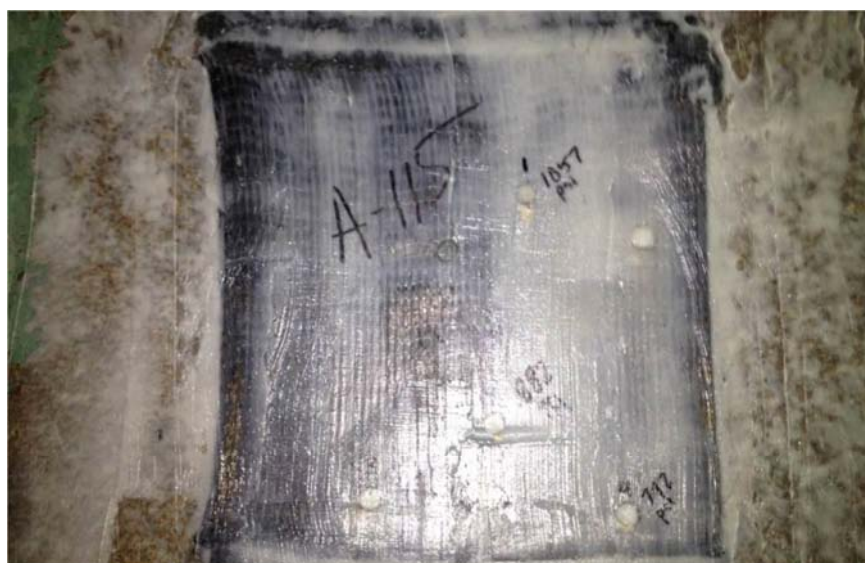
Figure 9. ASTM D4541 bond test typical patch

In order to validate the adequacy of the surface preparation and the adhesion strength of the carbon fiber strengthening system, the installer is to perform adhesion tests on the prepared concrete substrate adjacent to repair. These areas are to be cleaned, prepared, and covered with CFRP system test patches with minimum dimensions of 2 ft x 2 ft. The patch, as shown below in Figure 9, consists of two orthogonal layers of CFRP. Three adhesion tests are performed and reported in accordance with ASTM D4541. The remaining adhesion test panels are finish coated and remain in place for future testing purposes as needed.

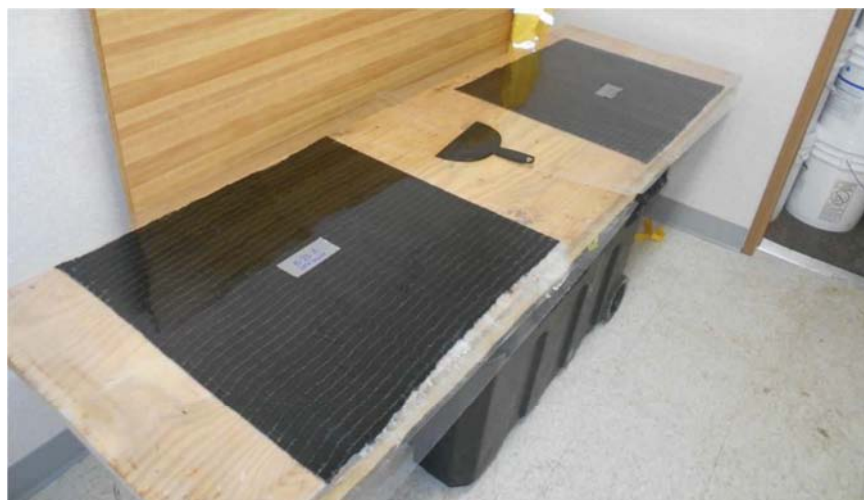
Figure 10. ASTM D3039 Tensile Testing panel preparation

In order to verify the material properties of the field applied CFRP system are in line with the properties used in the design, tensile tests are performed in accordance with ASTM D3039 on test panels which are field fabricated using the carbon fiber fabric, epoxy and saturation equipment used in the production runs for the field-installed CFRP lining system. The specimens are made with minimum dimensions of 12 in. by 12 in. and are prepared on a smooth flat surface overlaid with plastic (polyethylene or vinyl) sheeting (Figure 10).

Saturating epoxy is used to prime the surface, followed by the saturated CFRP fabric, and finally topped with more saturating epoxy. A cover of plastic sheeting is placed over the panel and the panel is squeezed to remove any bubbles and other surface irregularities to insure a smooth flat surface. The panel is labeled with time, date, sample panel number, fabric lot numbers, and epoxy batch numbers. It is then
